REPORT OF THE ROAD SAFETY AUDIT OF ROADS ON TARAWA ISLAND, REPUBLIC OF KIRIBATI

CLIENT:
World Bank
DATE:
21st September 2010

Phillip Jordan – Senior Road Safety Auditor
Short Term Road Safety Consultant to the World Bank

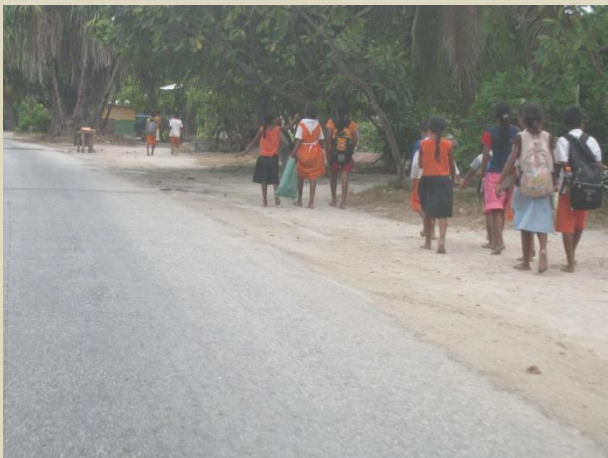
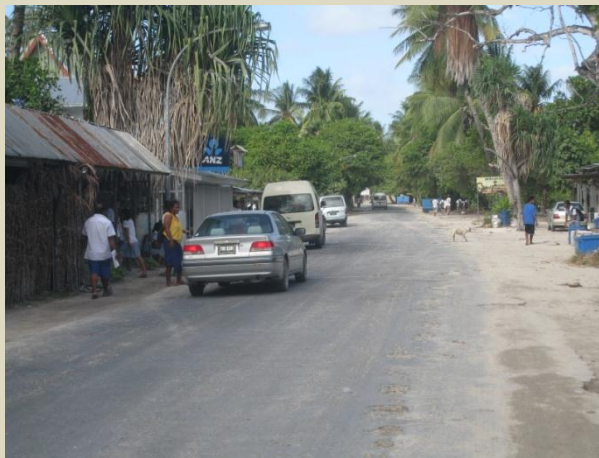
1.1	<p>The existing road makes no provisions for pedestrians to walk along the road or to cross the road. Walking is the main form of short distance transport in Tarawa and facilities need to be provided to assist pedestrians.</p> <p>To assist pedestrians walking along the road, sealed shoulders and, in one or two busy locations (such as near larger markets and larger schools), footpaths should be provided. Ensure the footpath is paved and made “all weather”.</p> <p>To encourage more use of the footpaths in Betio, Bairiki and Bikenibeu) – pave them and make them attractive for “all weather” use.</p> <p>To assist pedestrians at each causeway, a separate “all weather” footway should be formalised through the grass/trees on one side of the causeway.</p>	HIGH	<ul style="list-style-type: none"> Ensure that the cross section of the new road provides for sealed shoulders on both sides of the road at least 1.5m wide (and wider where space is available). In the 3 main town centres (Betio, Bairiki and Bikenibeu) pave the footpaths to encourage their use. Maintain speed control by the prudent use of speed restrictions signs (See 4.1) and road humps (See 4.2) Enhance the street lighting within the towns by installing new high pressure sodium lighting on both sides of the road wherever there is a footpath. On balance, pedestrian facilities such as zebra crossings are not recommended at this time (provided speeds are managed and sealed shoulders/footpaths are constructed).

<i>Many pedestrians walk along the road – at all times of day and night. Where the shoulder is wide (such as here) they can walk clear of traffic. However, there are other locations where they must walk on the road, and this exposes them to risk of being struck by a motor vehicle.</i>		<i>There are many locations – especially in the town centres – where pedestrians walk close to traffic. This is potentially a high risk activity and the risk will increase if speeds increase. Footpaths are needed through the town centres, and sealed shoulders are needed elsewhere.</i>

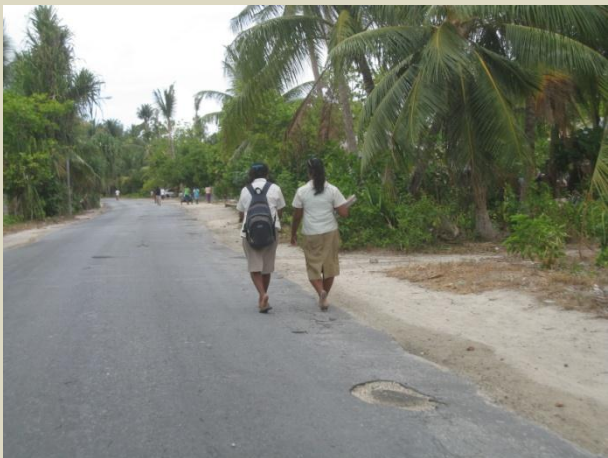
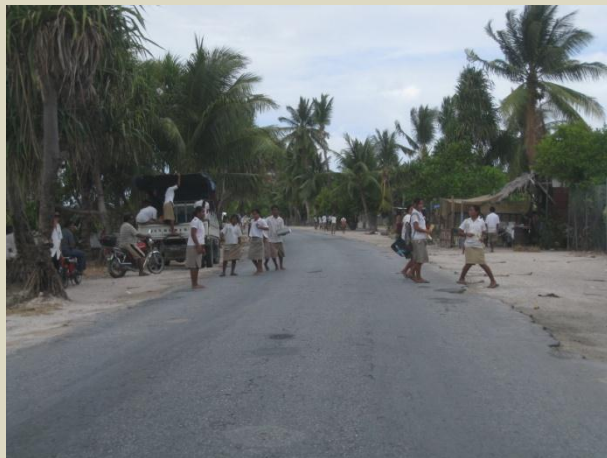
1.2	Pedestrians do not appear to have many difficulties crossing the road at present. Traffic volumes and speeds are low enough that there are many long gaps for pedestrians to (generally) amble across. However, there is a risk involved in rushing to catch a bus, and some younger pedestrians do not look when darting across. It is considered important to maintain speeds to 40km/h or less.	MED	<ul style="list-style-type: none"> At locations agreed within the local community – and with the number of humps dependent on the length of the road in each village – install a Watts profile road hump to control speeds. Each hump should conform to the given profile – 3700mm long by 100mm high, a segment of a circle. Each hump should be line marked (Australian Standard) and have a sign at the hump as well as another in advance. In villages, place a hump and a WELCOME sign on each approach to form a gateway treatment. The space the humps at 100m centres – one either side of schools and maneaba - as key starting locations.

<i>One of the busiest times of day is the mid afternoon when the schools finish for the day. Many students walk along the road, relying on sound (engines or horns) to decide when to move onto the shoulder.</i>		<i>Near schools there are often large numbers of school students crossing the road. It is unlikely that a crossing will be used or observed correctly by the pedestrians or the drivers. Managing vehicle speeds is thus important to assist safety in these circumstances.</i>

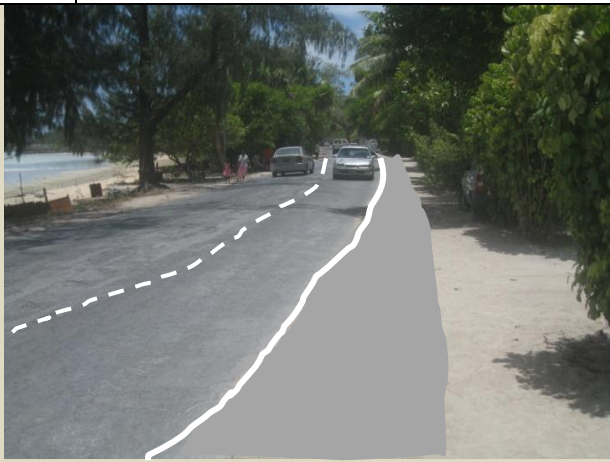
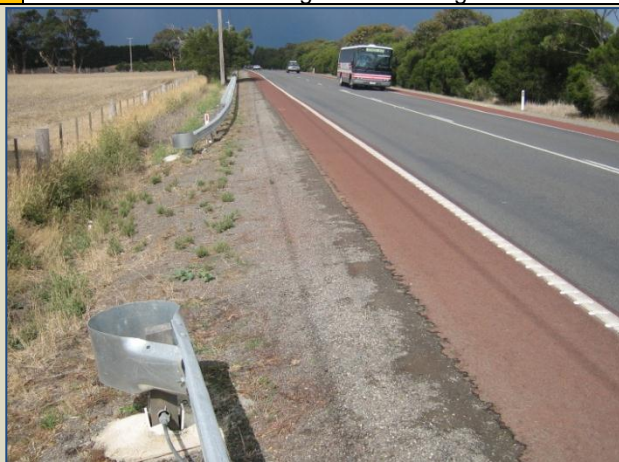
<p>A sealed shoulder (similar to that shown in this sketch) – minimum 1.5m wide is recommended along the full length of this road. Where space permits, widen this further, up to a max 2.5m. Ensure that a strong edge line is installed in white thermoplastic – to delineate at night and to reinforce the nature of the shoulder.</p>		<p>A sealed shoulder (such as this one in Australia) provides a safe smooth surface for pedestrians, bicyclists and motorcyclists. The red scoria in the sealed shoulder highlights it – a possible thought for the Tarawa road project</p>

2.1	<p>Lane widths of 3.5m will be acceptable. It is important to ensure that the shoulders are sealed, so that pedestrians are given an all weather path on which to walk. The sealed shoulder will also provide a better and safer place for the buses to stop – assuming that they will continue their practice of stopping anywhere, anytime. A minimum width of sealed shoulder of 1.5m should be designed, more if land permits.</p> <p>Sealed shoulders also provide a recovery area for errant vehicles. The six blackspots that have been investigated along the main road have a run-off-road pattern to them. The sealed shoulder and edge line should greatly assist in reducing these.</p>	MED	<ul style="list-style-type: none"> Seal the shoulders on both sides of the road for at least 1.5m width. If space permits, seal wider. Be prepared to settle for less sealed shoulder width if the road reservation does not permit for any reason – particularly at pinch points. Consider colouring the seal (See photo below). Buses will use the sealed shoulder for stopping – consideration should be given to the use of full depth pavement for the shoulder at critical bus stop locations, and at places where buses or trucks will turn into abutting properties. Use white thermoplastic edge lines (100mm wide) to demarcate the edge of the through lane.

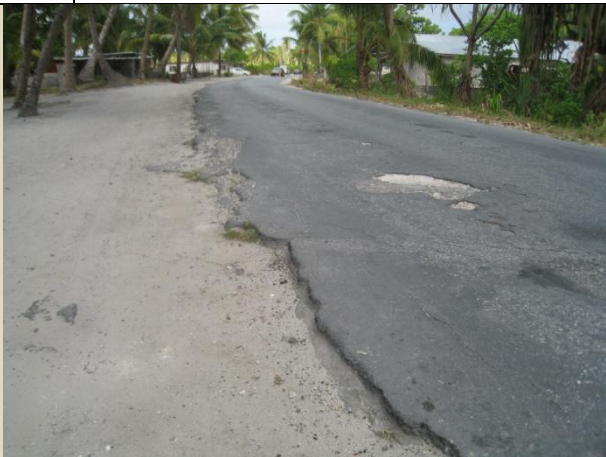
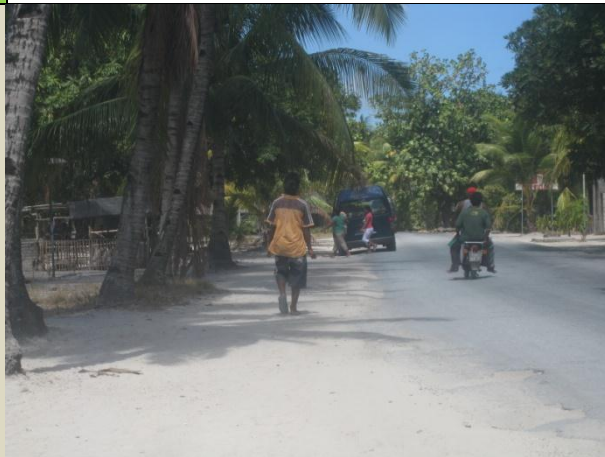
<i>The existing road has many lengths with deep drop offs from the pavement. Sealed shoulders will help to overcome this problem, and will help to preserve the road pavement.</i>		<i>There are many roadside hazards (especially trees) along this road. Rather than cut them down, or shield them with barrier, it is recommended that the sealed shoulder and the strong edge line be used to help to keep drivers and vehicles on the road. Some chevron alignment markers are recommended at sharp curves as well.</i>

3.1	The road at present lacks sealed shoulders. The sandy shoulders are – in many locations – up to 120mm below the existing pavement. This drop-off is a hazard for motorcyclists and smaller vehicles. Sealed shoulders provide a recovery area for errant vehicles and also assist with the preservation of the road pavement.	HIGH	<ul style="list-style-type: none"> Construct sealed shoulders. Aim for a min 1.5m wide sealed shoulder but go for a greater width in those locations where it is possible. Consider using a coloured scoria to highlight the shoulder as a “no drive” area. Install an edge line along both sides of the new road, over its full length.

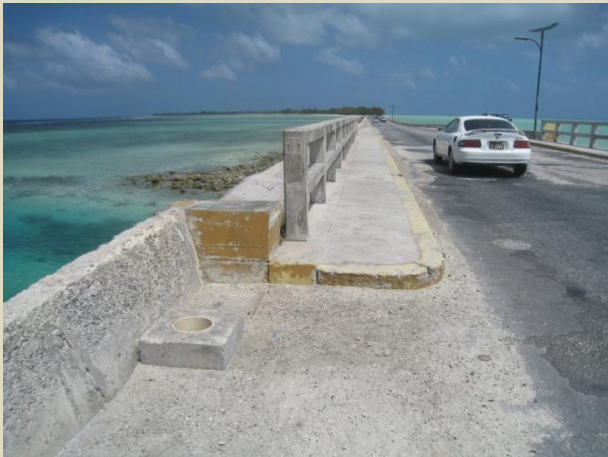
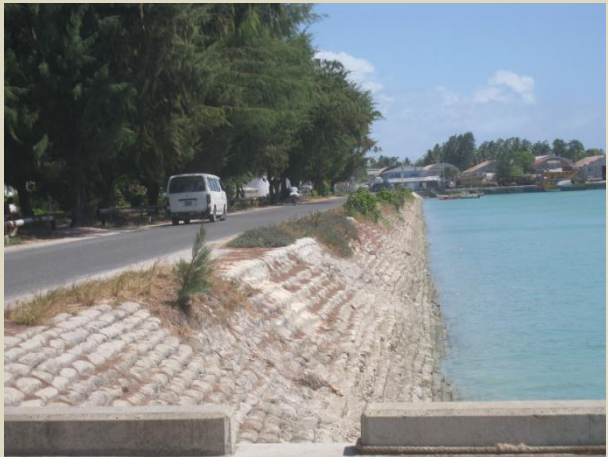
No.	SAFETY CONCERN	RISK	RECOMMENDATION	CLIENT RESPONSE
3.2	There are numerous trees and houses shops, and other fixed objects within the clear zone along this road. There are too many to individually highlight, and it is expected that removal of the trees will not be a favoured option. The installation of crash barriers is not recommended – such barriers will not fit in some parts because of inadequate widths for offsets and deflection. They will also cause “innocent hits” when buses/cars pull too close.	HIGH	<ul style="list-style-type: none"> Design the road with suitable line marking and associated delineation to minimise the risk of a vehicle leaving the road. Take into account especially the locations at each end of the causeways (where speeds will be highest) and ensure that delineation of the curves is excellent. At selected locations install 2-3 chevron alignment markers (CAM's) to delineate a sharp curve. Consider developing a program of tree removal to remove only those trees few that are closest to the road in the high risk locations (blackspots) at the end of the causeways.

<p>The bridge on the Betio causeway is narrower than the road cross section. The footpath and the bridge railing are road side hazards that present a risk to any vehicle that is a metre or two off path.</p>		<p>The Betio port road runs beside the sea – it requires crash barrier to prevent a vehicle from dropping 4m into the sea.</p>

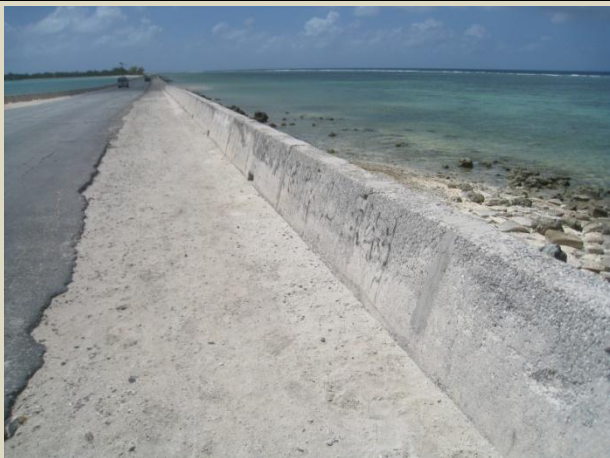
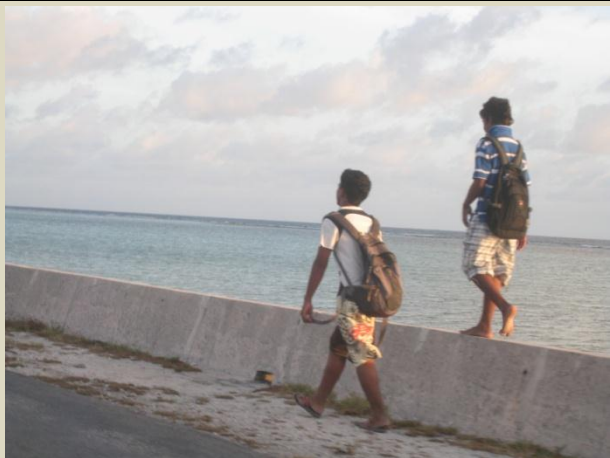
<i>This barrier is believed to be a retaining wall against the sea. As a crash barrier it has questionable structural capacity to resist an impact from an errant vehicle. While it is suspected that it can withstand an errant car travelling within the speed limit, it is doubtful that it could withstand an impact from a large truck, or even a small fully loaded bus travelling at 60-80km/h.</i>		<i>The barrier is lower than the normally acceptable height of 780mm. It is beyond the 3m clear zone width defined in this report and it could be retained as it is. However, the consequences of a large vehicle hitting this barrier at speed will be serious. It should be structurally reviewed, and most likely replaced with full height New Jersey barrier.</i>	
4 SPEED MANAGEMENT	There will be an increased need to manage speeds after the road is improved. The present road humps are helping to maintain lower speeds, but these are also causing noise, inconvenience and discomfort (as well as likely vehicle damage). Unfortunately, for safety road, humps will continue to be the treatment of best effect.		<ul style="list-style-type: none"> • Install road humps at the entry to each village, together with a WELCOME sign. • Install them also at locations near schools, churches, markets and maneaba where they are needed. • In addition, install road humps through all 40km/h speed zones at centres of no more than 1000m.

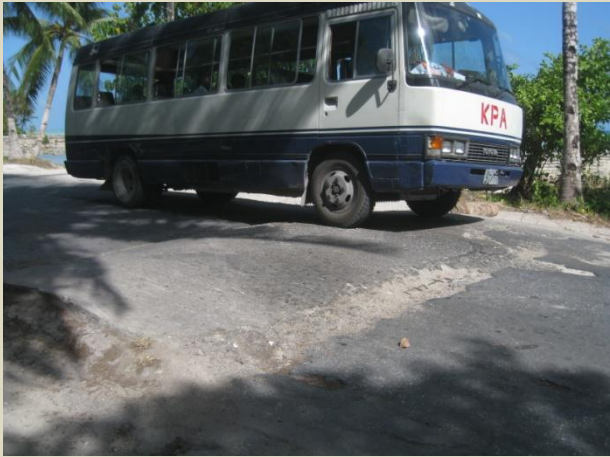
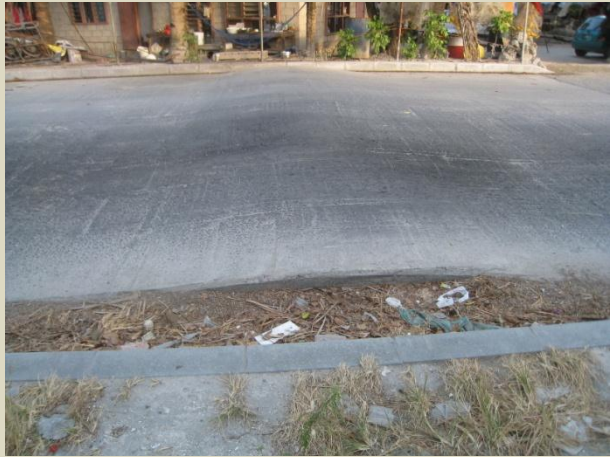
No.	SAFETY CONCERN	RISK	RECOMMENDATION	CLIENT RESPONSE
4.2	Road humps appear to be accepted by the community. At present they seem to come in three differing profiles – the smaller one is particularly hazardous. They are not well signed and they have no line marking. Humps are recommended for the new road, but only on the basis that they are signed correctly and line marked.		<ul style="list-style-type: none"> All humps should conform to the same profile. The concrete humps in use at present appear to be a slightly modified Watts profile hump (a segment of a circle 3700mm long by 100mm high). Small, short humps must not be used. Each hump should be signed in advance <u>and</u> at the hump. Each hump should have stripped markings (in accordance with the Australian Standard). Wherever possible, the humps should be located below a street light.

<p>Road humps are an accepted part of the Tarawa road. They are neither consistent nor conspicuous at present. There are varying profiles; there are no markings; the advance warning signs vary; there are no location signs.</p>		<p>This road hump (in Betio) appears to be a newer hump. It appears to almost conform to the Watts profile (it is about 50% higher than the standard Watts profile) – but is otherwise an acceptable profile. It is recommended that this type of hump be the only hump used in Tarawa. Each hump requires standard line marking and a sign at each, as well as a sign in advance.</p>

5.2	There are numerous road humps along the existing road. They seem to be well accepted by the community, but they are in three different shapes, and they are poorly signed. They have no line marking.	HIGH	<ul style="list-style-type: none"> Ensure that all road humps are of one shape (profile) only. The new hump used in Betio is recommended. Ensure each hump is line marked (with Australian Standard markings). Ensure each hump has an advanced warning sign 50m in advance on each approach, plus a hump location sign at the hump. Extend each hump to include the sealed shoulder. Where a hump is placed where vehicles may drive around it, ensure that there is kerbing placed beside the hump to prevent such action.

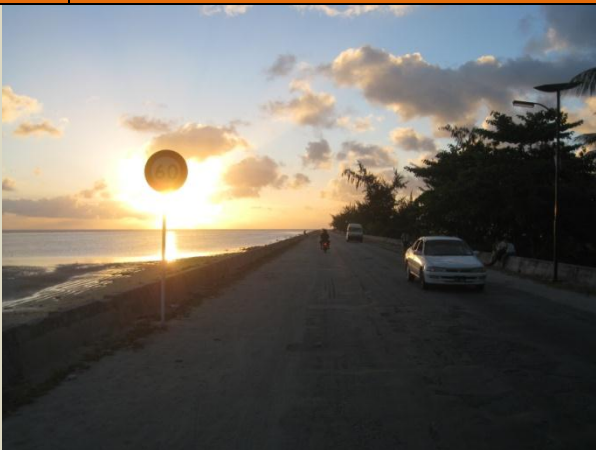
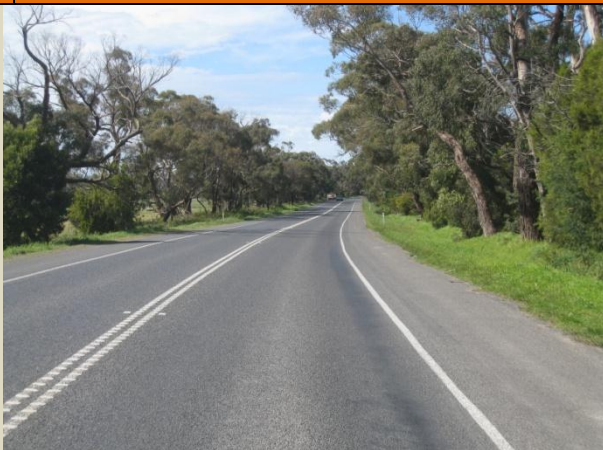
No.	SAFETY CONCERN	RISK	RECOMMENDATION	CLIENT RESPONSE
5 SIGNS, LINE MARKING AND ROAD HUMPS	There are no lines on the road. Without longitudinal lines, drivers may have difficulty remaining in their correct lane. Without lateral lines, drivers may not know where to stop or give way. There are few signs along the road. Those that do exist are warning signs for the humps, and some speed restriction signs. However, there is no consistency in the use of the type of these signs. There are no direction signs and no delineation.	MED	<ul style="list-style-type: none"> Ensure that lines are provided. Use thermoplastic for durability in the tropical weather. Ensure that correct and conspicuous signs (warning, direction, regulatory) are used on the new road.

<i>The road lacks lines at present. It is a (generally) east/west road and sun glare is an issue. Edge lines and a centre line are required for the new road.</i>		<i>This highway in Australia benefits from a sealed shoulders, edge lines and a centre line. In this case the centre line prohibits overtaking – something that may need to be considered on Tarawa depending on the radius of the curves.</i>	
6 SAFETY DURING ROADWORKS	During the inspections of the road there were long term works underway on one causeway that caused one lane to be closed. There was also short term patching underway in one of the villages that caused a lane closure. Neither work site was well signed – there was no speed reduction, no advanced warning of the lane closure, no information or traffic control for the one lane operation. This raises serious questions about whether the contractor will use safe procedures for the construction of the road.	MED	<ul style="list-style-type: none"> Ensure that the Specifications for the project clearly require the Contractor to construct this road by complying with Australian Standard AS1742.7 (Code of Practice for Road Works) requirements. Ensure that drivers/riders are given advanced warning of the worksite, a reduced speed limit through the work zone, and clear traffic control (Stop/Slow baton) to assist them through the works when a lane is closed.

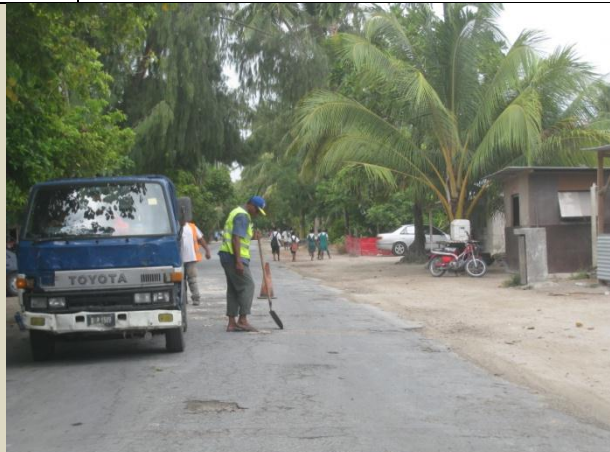
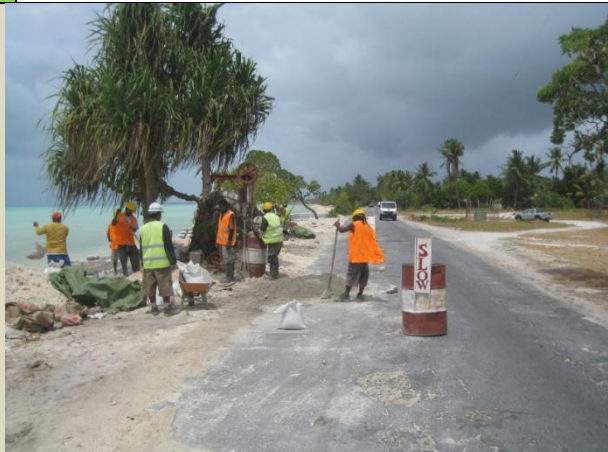
No.	SAFETY CONCERN	RISK	RECOMMENDATION	CLIENT RESPONSE
6.2	Workers were wearing high visibility vests. This is a good sign. It will be important for all road workers on the new road to wear high visibility vests	LOW	<ul style="list-style-type: none">Write into the Specifications for the work that all road workers are to wear high visibility vest at all times while on the job.Specify that the Contractor must comply with AS1742.7 Code of Practice for Road works

<i>The short term patching was being undertaken with no advanced warning, no speed control and no management of the one lane that was left open to serve both directions of travel.</i>		<i>This work on the seawall along a causeway has been on-going for some time. It also fails to warn drivers in advance, to control speeds, or to control the traffic into a single lane. Such practices should be overcome during the roadworks of the new road project.</i>

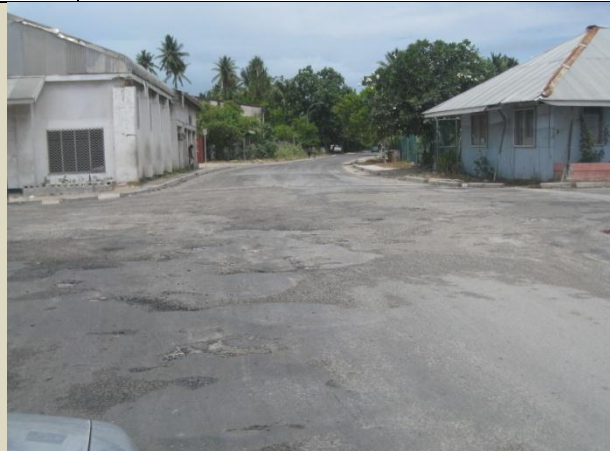
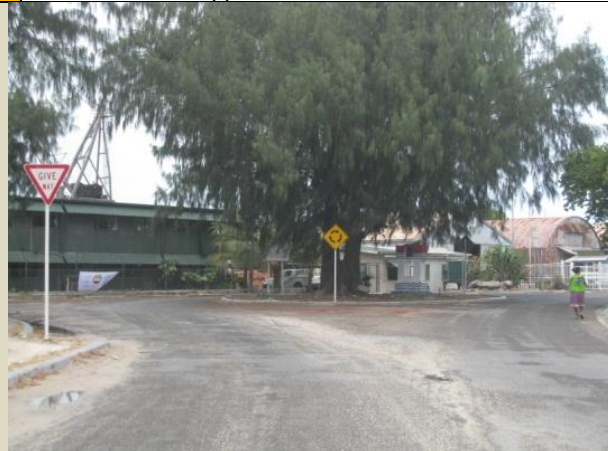
No.	SAFETY CONCERN	RISK	RECOMMENDATION	CLIENT RESPONSE
7.2	The other intersection is 25m west of the Ministry of Public Works. It is a cross road intersection, but it is not conspicuous. When the road surface is rehabilitated there will be an increased risk that drivers will overshoot this intersection without realising it is there.	MED	<ul style="list-style-type: none">When the road is rehabilitated, install new stop signs on the north and south (side road) approaches.Paint Stop lines (in thermoplastic) across the side roads at the stop signs.Mark a centre line along the main road here.Place an advanced warning sign (cross road ahead) 50m in advance of the intersection on the main road on both approaches.

<i>This cross road intersection in Betio (just 25m from the Ministry of Public Works) lacks conspicuity. There is a risk of drivers “overshooting” this intersection. When the pavement is rehabilitated, Stop lines should be installed across the minor roads – and a centre line installed along this main road. Warning signs for the cross road should be installed 50m in advance of the junction on both main road approaches.</i>		<i>This junction has a roundabout warning sign – but it has Give Way signs. The sand on the pavement indicates the travel paths. When rehabilitation takes place, this should be formalised as a roundabout. The advanced warning signs should be moved to 50m in advance of the junction. A splitter island should be marked in thermoplastic on this western approach. Regulatory roundabout signs should replace the GW sign on each approach.</i>

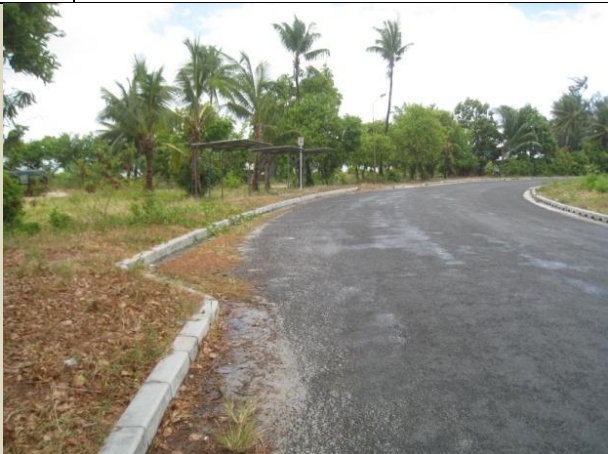
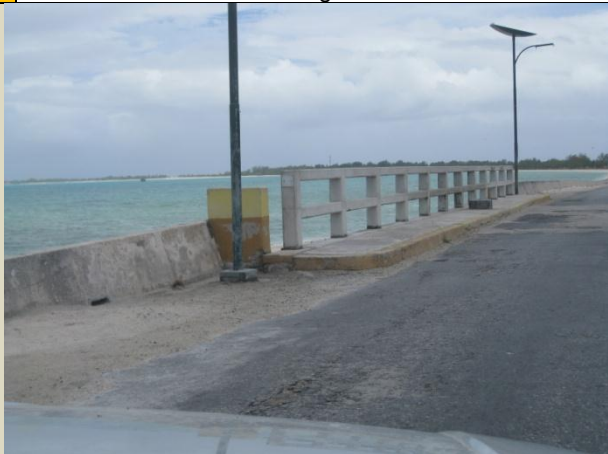
No.	SAFETY CONCERN	RISK	RECOMMENDATION	CLIENT RESPONSE
	such a way that pedestrians are attracted to use them, rather than walking on the roads.			
7.5	The bridge on the Betio (Nippon) Causeway is the only bridge in this project. It is narrower than the Causeway cross section and thus the footpath and the bridge railings are roadside hazards within the 3m clear zone.	MED	<ul style="list-style-type: none"> Either widen the bridge so that the bridge railing is in line with the barrier along the causeway retaining wall, or remove the footpath (if possible) and then use W beam steel barrier to shield the railing. Such barrier will need to be carefully and strongly attached to the causeway retaining wall so that it redirects an impacting vehicle, rather than pocketing them. A thermoplastic edge line and reflectors should also be installed to aid night time delineation

<p><i>Betio has a number of indented bus lay-bys. This concept should be extended to other points along the main road so that buses are encouraged to stop at set points. These points should be decided in consultation with the bus operators. Shelters and a street light should also be installed as a standard fixture at each lay-by.</i></p>		<p><i>This is the only bridge along the main road. It presents a roadside hazard to drivers/riders. The bridge should be widened and W beam crash barrier installed to shield the bridge railings and parapet from being struck. If widening is not possible, W beam barrier should be installed across the bridge, securely fastened to concrete barrier at either side. A thermoplastic edge line and reflectors should also be installed to aid night time delineation.</i></p>

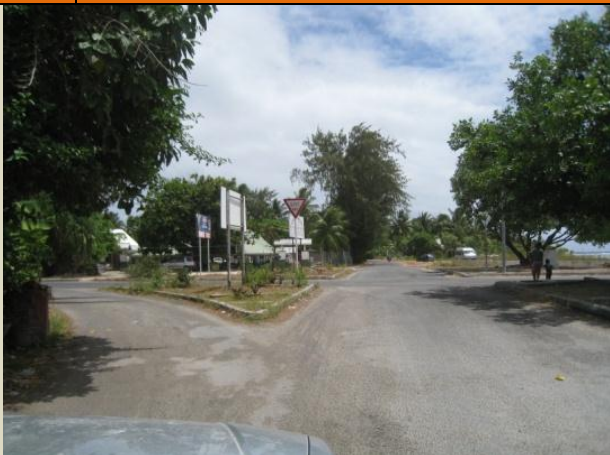
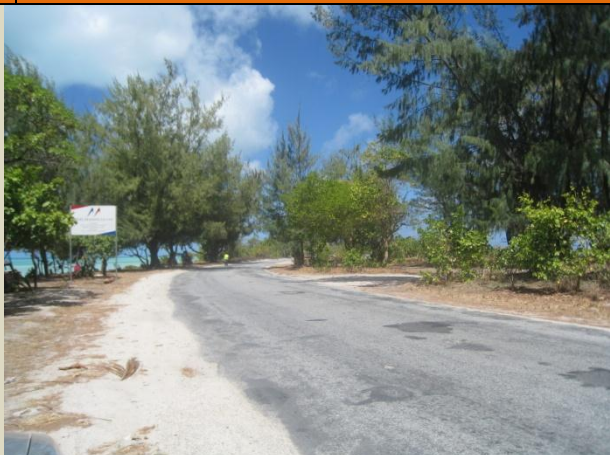
7.6	The intersection just east of the Nippon Causeway (at Mary's Motel) is too complex for the needs of this area and a little too narrow for the side road movements. The intersection does not need left turn slip lanes (it is difficult to see safely due to the angle). They take space that should be allocated to the side road.	LOW	<ul style="list-style-type: none"> Reconstruct this intersection. Remove all the left turn slip lanes. Convert this to a conventional cross road intersection. Construct narrow splitter islands in the side road to regulate turns in and out from the main road. Use Stop signs and lines to control the traffic.

<i>This cross road intersection at Mary's Motel, immediately east of the Betio Causeway, has been "over designed". It does not need the left turn slip lanes, and these are too acutely angled. The side road is too narrow for turning vehicles to safely enter. When reconstruction takes place, move the islands and create a simple cross road, with splitter islands in the minor road approaches</i>		<i>This curve – at the western end of the second causeway (just east of Ambo) requires 2-3 chevron alignment markers to improve delineation at night. It is a reported blackspot with several run-off-road crashes reported. Some of the lesser trees could be removed.</i>

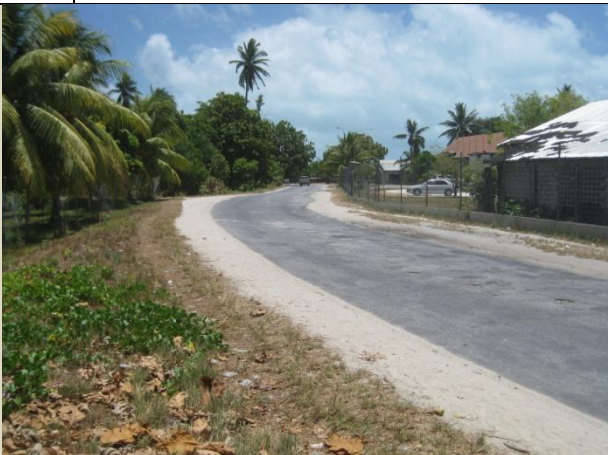
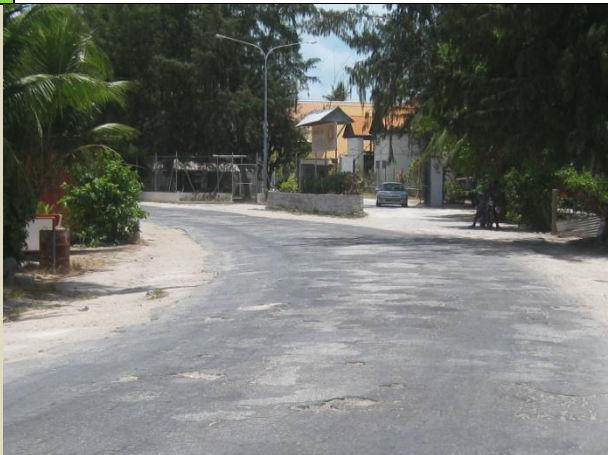
7.9	There is a blackspot at the reverse curves at the Otintaai Hotel. At these pair of reverse curves, drivers apparently fail to safely negotiate these curves especially after dark. There is a need to enhance night time delineation on these curves.	MED	<ul style="list-style-type: none"> In addition to the centre line and the edge lines here, install 3 chevron alignment markers on the outside of each curve to face traffic.

No.	SAFETY CONCERN	RISK	RECOMMENDATION	CLIENT RESPONSE
7.10	The entrance into the hotel is a Y junction on a curve. Such junctions present risks – head on and side swipe collisions can occur if drivers select wrong gaps to enter the hotel. During reconstruction, it is recommended that this entrance be modified in consultation with the hotel owners.	LOW	<ul style="list-style-type: none"> Aim to remove the triangular walled island in the entrance to the hotel. Try to simplify the entrance – maximising sight line for both directions for exiting traffic.

<p><i>There is a blackspot at the Otintaai Hotel. There is a pair of reverse curves and drivers apparently fail to safely negotiate these curves especially after dark. It appears that the road may once have been straight here – passing immediately in front of the hotel. The road appears to have been re-aligned to allow the hotel to expand. If so, this is unfortunate as the curves are tight enough to restrict safe overtaking.</i></p>		<p><i>The entrance into the hotel is a Y junction on a curve. Such junctions present risks – head on and side swipe collisions can occur if drivers select wrong gaps to enter the hotel. During reconstruction, it is recommended that this entrance be modified in consultation with the hotel owners</i></p>

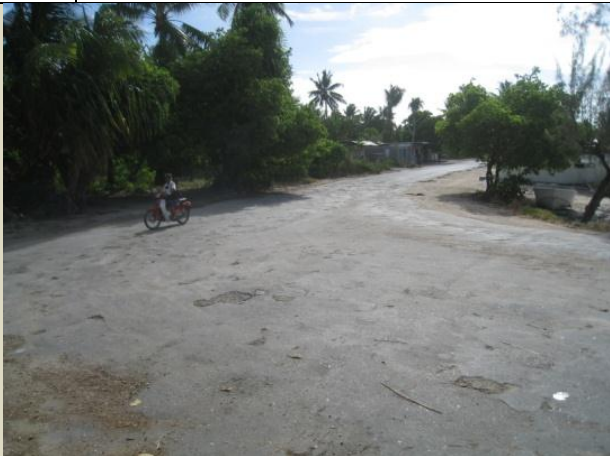
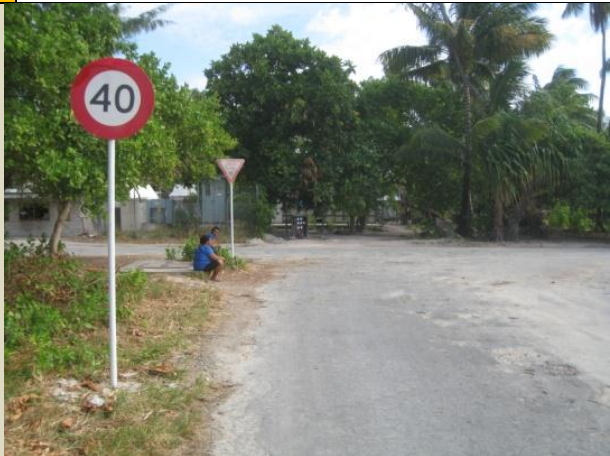
7.11	The T junction where the Airport Road intersects with the main road requires attention. It is a known blackspot. It is unclear which road should have “priority” but for now it is best to assume the Airport Road traffic should stop and give way. There is a risk of a vehicle from the airport “overshooting” this intersection. Work needs to be done to reduce this risk.	MED	<ul style="list-style-type: none"> Install a 20m long, 1.8m wide splitter island in the Airport Road on the approach to this intersection. Place a second Give Way sign on the island. Take the centre line marking to the left of the island as an edge line, and hatch the area at both ends of the island. Allow for turning movements at the intersection (ie place the splitter island back a couple of metres). Relocate the 40km/h speed restriction sign around the corner, away from the intersection. Install a direction sign in advance of the intersection, pointing to Bairiki and Betio. Repeat this on the far

<p>The T junction where the Airport Road intersects with the main road requires attention. It is a known blackspot. It is unclear which road should have "priority" but for now it is best to assume the Airport Road traffic should stop and give way.</p>		<p>This 40km/h speed restriction sign is poorly placed. It distracts attention at a time when drivers should be focussing on more important and immediate issues. The Give Way sign should be renewed, a long splitter island installed in the Airport Road and a duplicate GW sign installed on it. A bi-directional hazard marker should be installed on the far side of the junction to reduce the risk of a vehicle overshooting at night. A street light is desirable.</p>

No.	SAFETY CONCERN	RISK	RECOMMENDATION	CLIENT RESPONSE
			<p>side of the intersection, just above a bi-directional hazard board (black and white).</p> <ul style="list-style-type: none"> Install a street light at this intersection to highlight it.
