Appendix I:
UXO Findings Report

POST ACTIVITY REPORT

**KIRIBATI ROAD REDEVELOPMENT PROJECT – BETIO
ISLAND**

**100% UNEXPLODED ORDNANCE REMEDIATION
SERVICES**

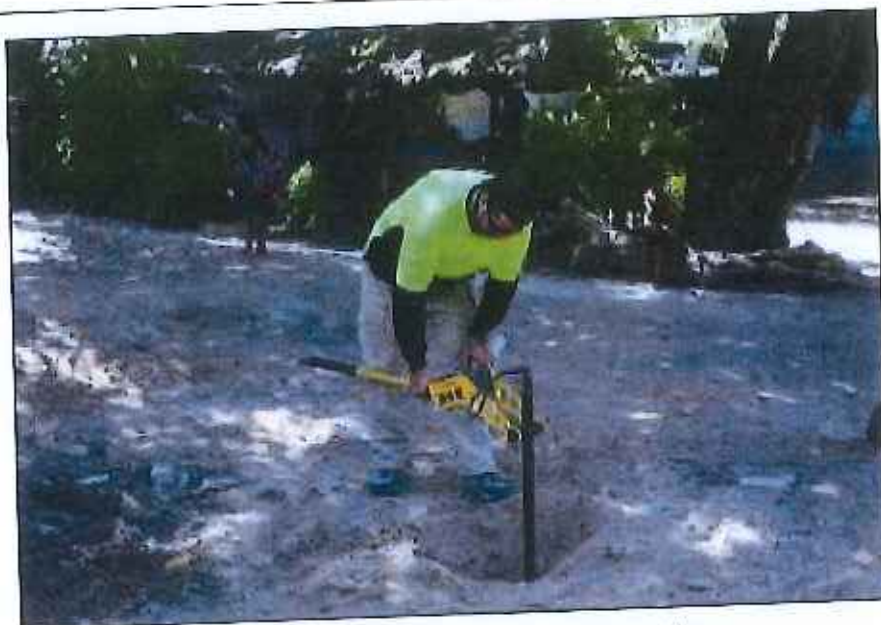
Plate 2: Site Layout and Magnetometer Use

Each FR/UD/WMR had its centerline marked out by the clients surveyor at regular intervals along that route unless otherwise specified. Using the clients specified width, each task was then broken into 10-20m blocks and string lines used to break those blocks into 0.5m lanes. Each lane was then walked with a magnetometer and all ferrous items excavated and removed either manually or using mechanical means. Plate 2 shows the lane layout and the 4032 magnetometer in use.

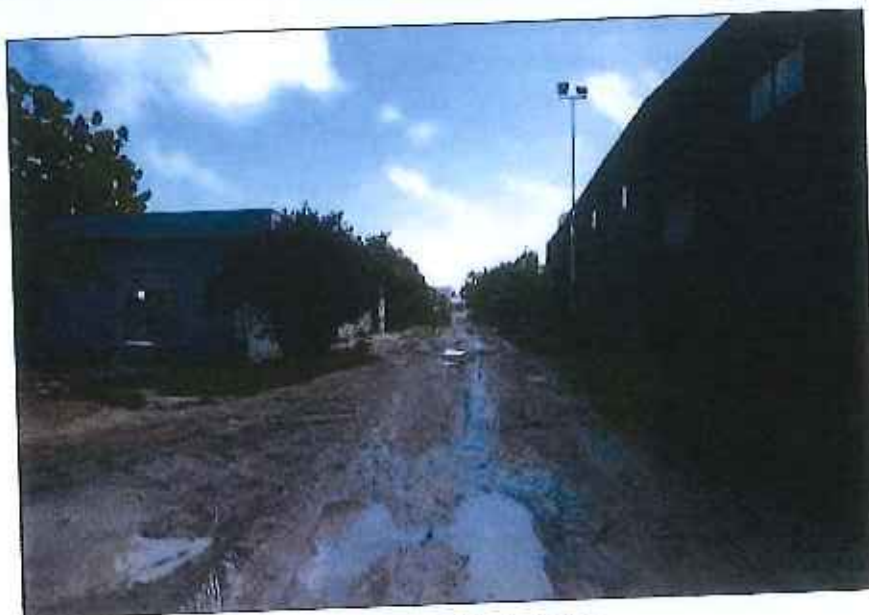
Plate 3: FR01 Works Image

FR01 has a specified width of 5m (kerb to kerb) and an overall length of 180m giving a total area of 900m². The centreline of this route was marked by the clients surveyor at regular intervals. Where possible working room was searched. UXO survey and investigation was conducted over the period 15-16 Aug 2014 with 163 anomalies investigated all of which were general scrap. There are eight anomalies remaining under the chipseal between CLO-20 however they are situated directly on top of or in the vicinity of HV power. Several other anomalies were removed in the vicinity of this power easement however the presence of interference from the HV power may mask deeper anomalies. HV Power bisects the road in several places and runs up the western edge of the road.

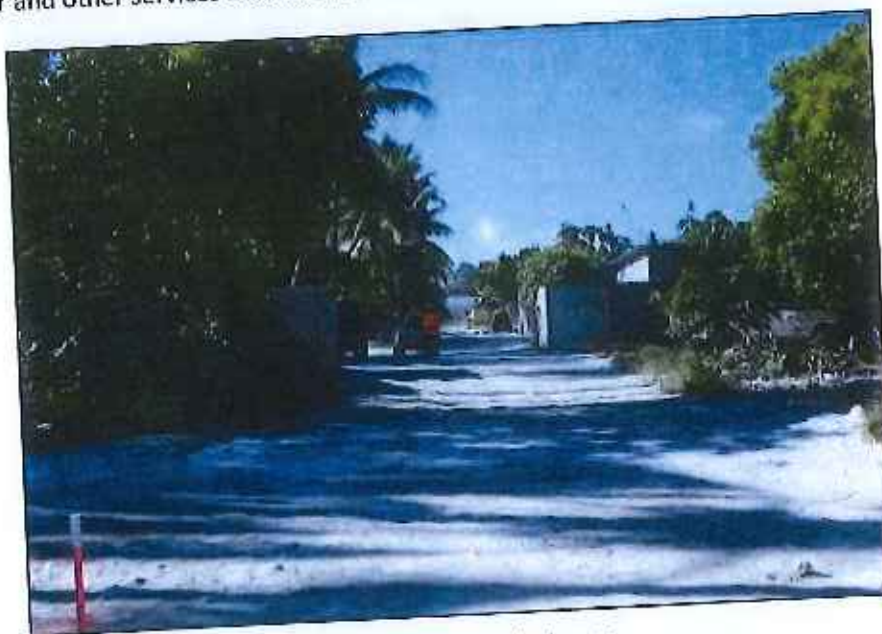
Plate 4: FR02 Works Image

FR02 has a specified width of 5m (kerb to kerb) and an overall length of 348m giving a total area of 1738m². The centreline of this route was marked by the clients surveyor at regular intervals. Where possible working room was searched. UXO survey and investigation was conducted over the period 22-23 Aug 2014 with 353 anomalies investigated, all general scrap. Two shipping containers impinged upon the route and the area underneath them was not searched. Towards the Northern end of this route, power and other services bisect the route in several places.

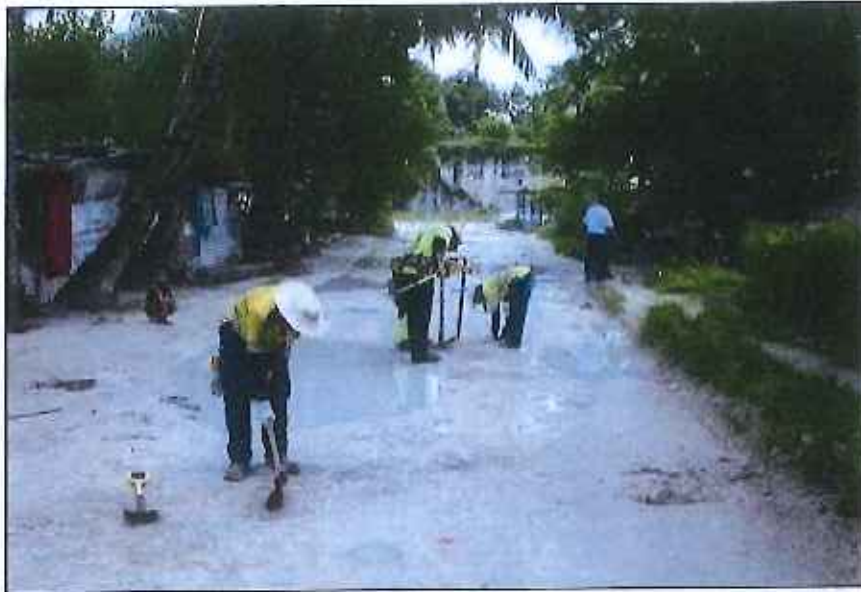
Plate 5: FR03 Works Image

FR03 has a specified width of 6m (kerb to kerb) and an overall length of 212m giving a total area of 1276m². The centreline of this route was marked by the clients surveyor at regular intervals. Where possible working room was searched. UXO survey and investigation was conducted over the period 05-06 Aug 2014 with 195 anomalies investigated resulting in two items of EOW being removed with the remaining anomalies general scrap. There is household power running down both sides of the road and the sewer main was discovered in the NE corner.

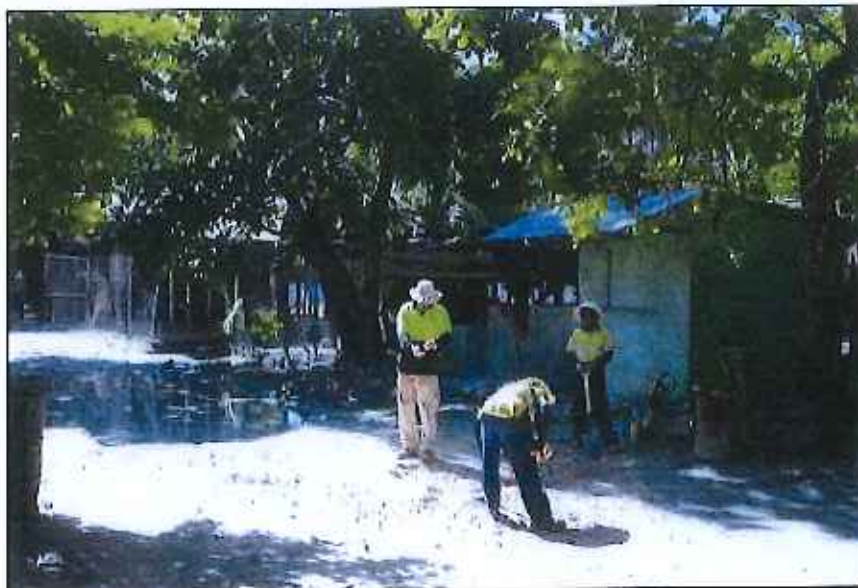
Plate 6: FR04 Works Image

FR04 has a specified width of 3m (kerb to kerb) and an overall length of 340m giving a total area of 1020m². The centreline of this route was marked by the clients surveyor at regular intervals. Where possible working room was searched. UXO survey and investigation was conducted over the period 20-22 Aug 2014 with 342 anomalies investigated resulting in one item of EOW being removed with the remaining anomalies general scrap. The road narrows substantially in some sections so only those areas accessible were searched.

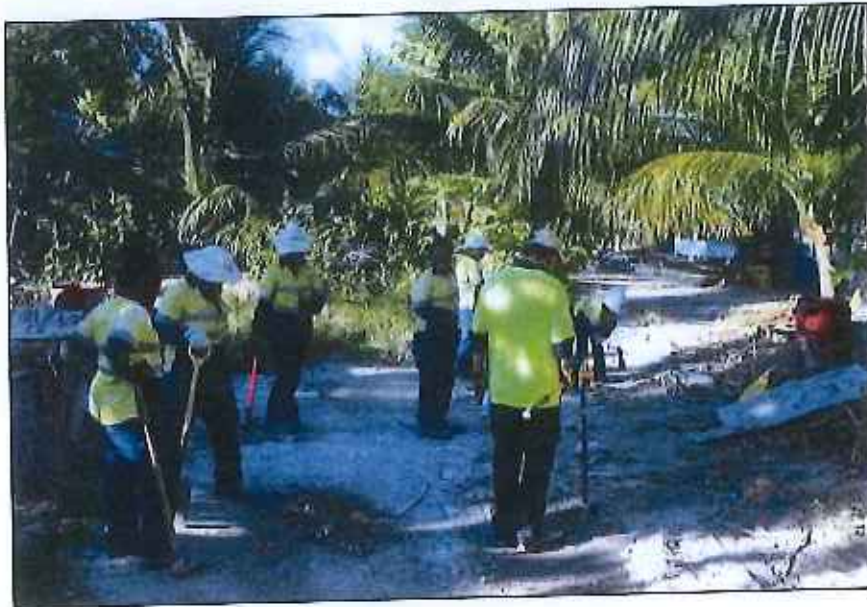
Plate 7: FR04A Works Image

FR04A has a specified width of 4m (kerb to kerb) and an overall length of 80m giving a total area of 320m². The centreline of this route was not marked and, on the clients instruction, the most suitable centreline was selected. Where possible working room was searched. UXO survey and investigation was conducted on 27 Aug 2014 with 61 anomalies investigated, all general scrap. The road does narrow significantly in places making it difficult to achieve the nominal width.

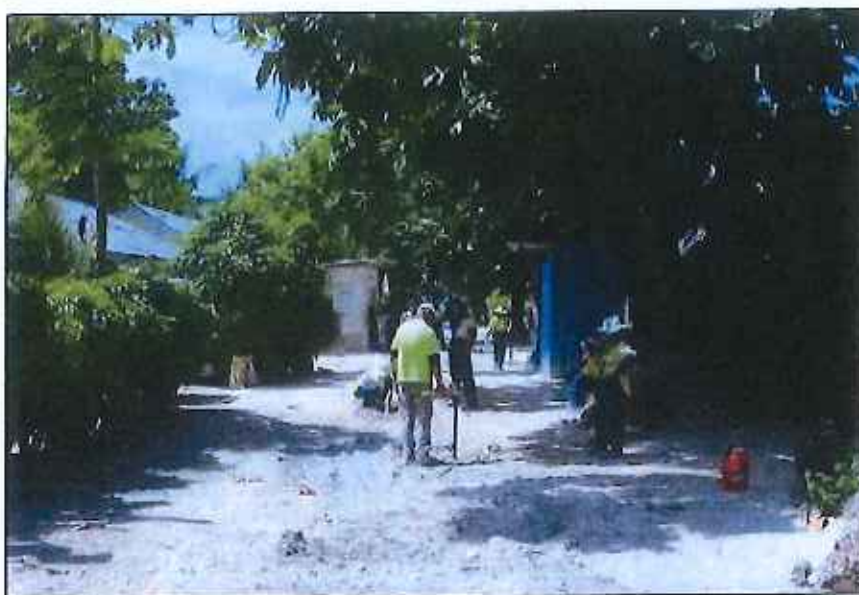
Plate 8: FR05 Works Image

FR05 has a specified width of 4m (kerb to kerb) and an overall length of 290m giving a total area of 1158m². The centreline of this route was marked by the clients surveyor at regular intervals. Where possible working room was searched. UXO survey and investigation was conducted over the period 20-22 Aug 2014 with 399 anomalies investigated resulting in one item of UXCO and two items of EOW being removed with the remaining anomalies general scrap.

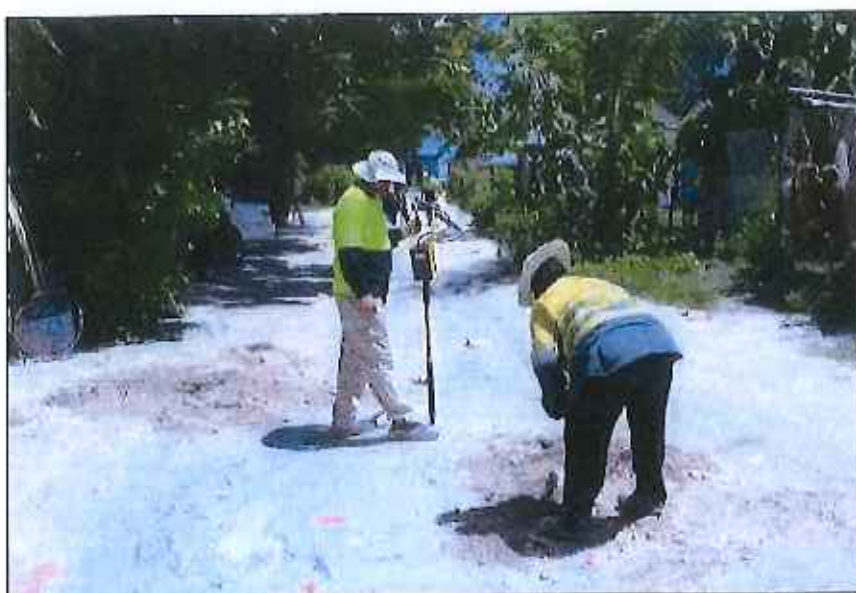
Plate 9: FR06 Works Image

FR06 has a specified width of 4m (kerb to kerb) and an overall length of 413m giving a total area of 1651m². The centreline of this route was marked by the clients surveyor at regular intervals. Where possible working room was searched, UXO survey and investigation was conducted over the period 18-19 Aug 2014 with 1286 anomalies investigated resulting in 569 items of EO, 10 items of SAA and 340 items of EOW being removed with the remaining anomalies general scrap. Two Japanese skeletons were also exhumed on this route. Power runs bisects the road in several places and runs along the north eastern edge of the road. Sewer runs along the opposite edge.

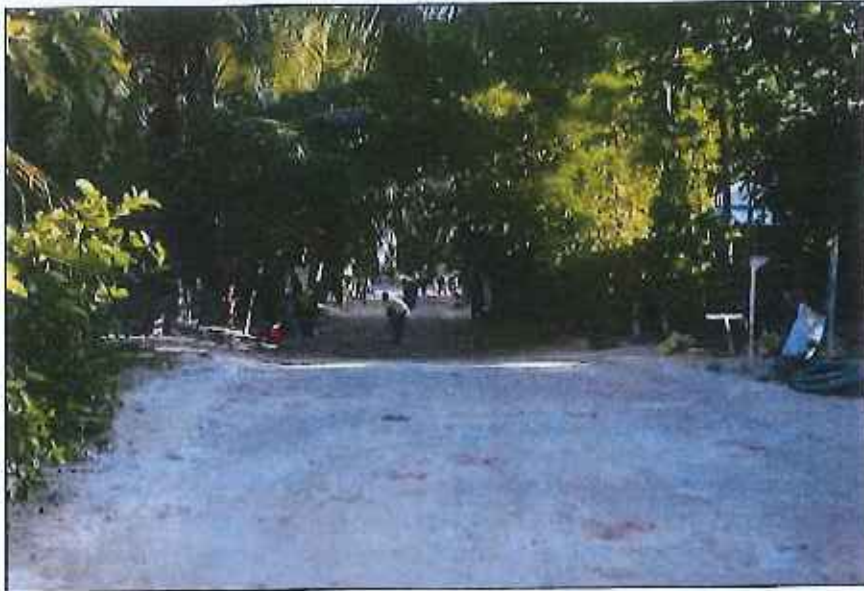
Plate 10: FR07 Works Image

FR07 has a specified width of 5m (kerb to kerb) and an overall length of 182m giving a total area of 910m². The centreline of this route was marked by the clients surveyor at regular intervals. Where possible working room was searched. UXO survey and investigation was conducted over the period 14-15 Aug 2014 with 247 anomalies investigated resulting in two items of EOW being removed with the remaining anomalies general scrap. There are numerous shallow services such as power, water and communications cables bisecting and running along this route.

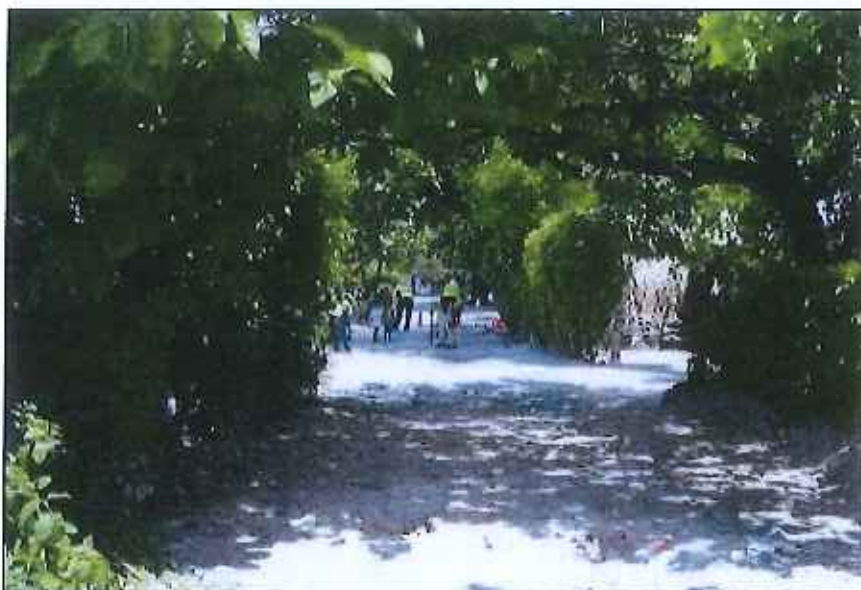
Plate 11: FR08 Works Image

FR08 has a specified width of 4m (kerb to kerb) and an overall length of 730m giving a total area of 2918m². The centreline of this route was marked by the clients surveyor at regular intervals. Where possible working room was searched. UXO survey and investigation was conducted over the period 12-14 Aug 2014 with 857 anomalies investigated resulting in one item of UXO, one item of EO, one item of SAA and 24 items of EOW being removed with the remaining anomalies general scrap. There are numerous shallow services such as power, water and communications cables bisecting and running along this route.

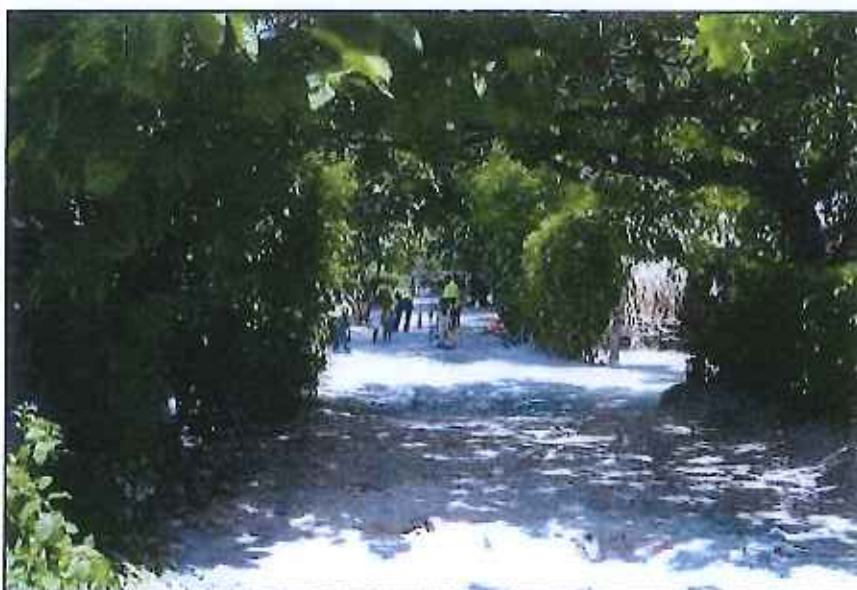
Plate 12: FR09 Works Image

FR09 has a specified width of 3.5m (kerb to kerb) and an overall length of 80m giving a total area of 280m². The centreline of this route was marked by the clients surveyor at regular intervals. Where possible working room was searched. UXO survey and investigation was conducted on 12 Aug 2014 with 86 anomalies investigated resulting in two items of EOW being removed with the remaining anomalies general scrap. There is household power running along both verges of the road.

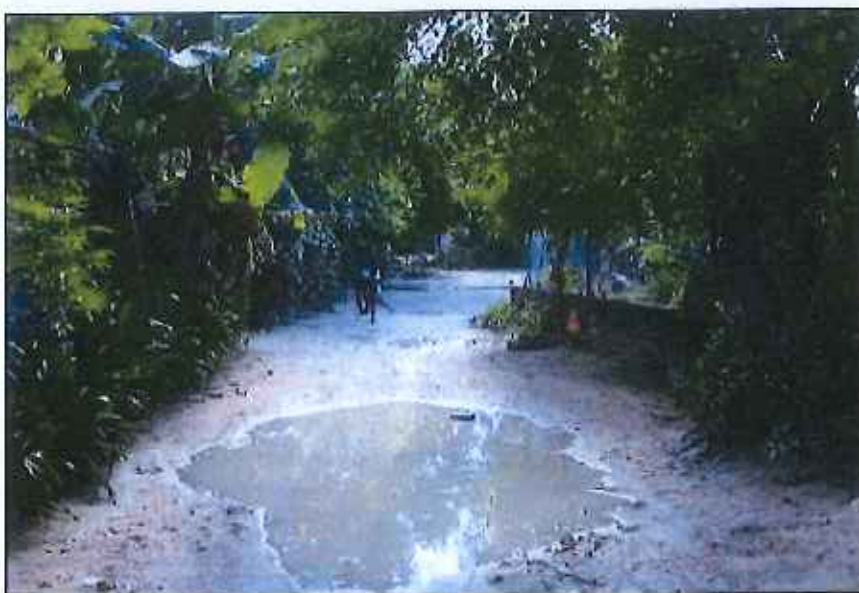
Plate 13: FR10 Works Image

FR10 has a specified width of 4m (kerb to kerb) and an overall length of 426m giving a total area of 1705m². The centreline of this route was marked by the clients surveyor at regular intervals. Where possible working room was searched. UXO survey and investigation was conducted over the period 06-11 Aug 2014 with 398 anomalies investigated resulting in six items of EOW being removed with the remaining anomalies general scrap. A further 29 anomalies remain under the chipseal between CL355-425 as per the clients instructions. There is household power bisecting the road in several places, a sewer main outside Red Beach School and communications cables running along the Northern kerb.

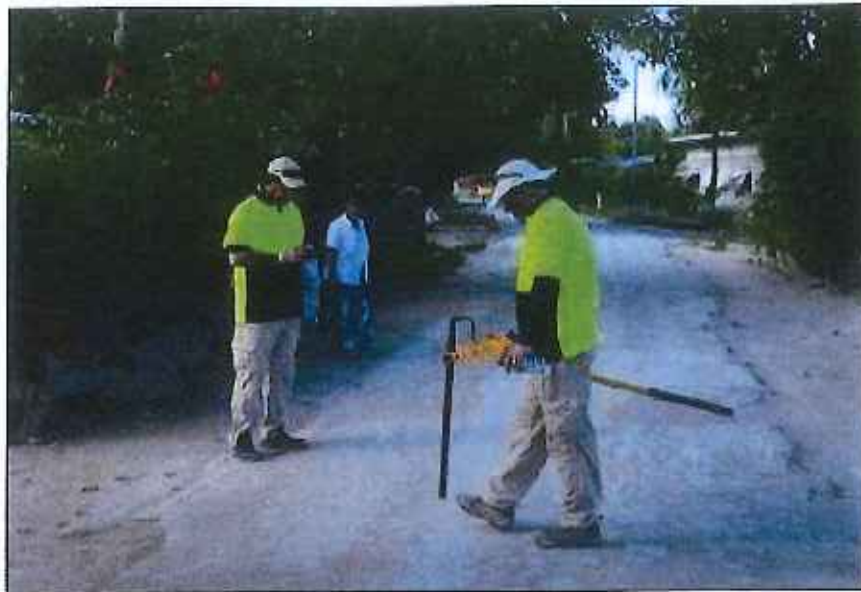
Plate 14: FR11 Works Image

FR11 has a specified width of 4.5m (kerb to kerb) and an overall length of 462m giving a total area of 2075m². The centreline of this route was marked by the clients surveyor at regular intervals. Where possible working room was searched. UXO survey and investigation was conducted over the period 08-11 Aug 2014 with 232 anomalies investigated resulting in five items of EOW and one item of SAA being removed with the remaining anomalies general scrap. A Japanese gun mount was discovered midway along the route approx 400mm below the surface and left in situ. A further 94 anomalies remain under the chipseal between CL0-200 as per the clients instructions. There is household power bisecting the road in several places and communications cables running along the Eastern kerb adjacent to FR10.

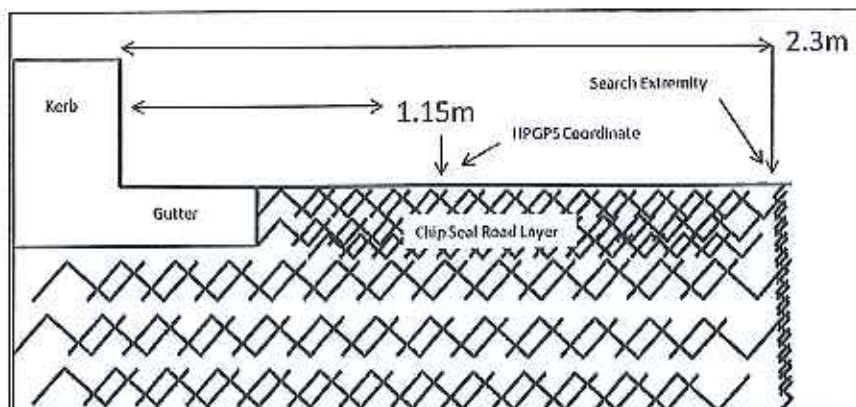
The WMR has a specified width of 2m, not including the gutter, (as per Figure 3) and an overall length of 2400m giving a total area of 4800m². The majority of the centreline of this route was not marked and, on the clients instruction, a specific measurement was taken from the kerb. No working room was searched. UXO survey and investigation was conducted during the period 24-25 Aug 2014 with 117 anomalies investigated, all general scrap. Several very large metallic anomalies between 1.5m-2m in depth were left in place. Power, communications and the Sewer also run along this same easement.

Figure 3: WMR Client Specified Centreline

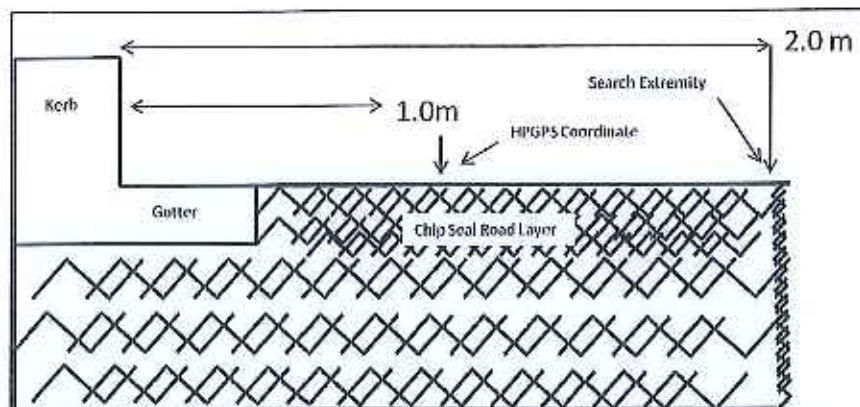
UD03 has a specified width of 2m (as per Figure 4) and an overall length of 240m giving a total area of 480m². The centreline of this drain was paint marked by the client but not surveyed. Minimal working room was searched. UXO survey and investigation was conducted on 27 Aug 2014 with 44 anomalies investigated, all general scrap. Power bisects this easement in several places.

Figure 4: Client Specified Centreline for all UD (unless otherwise indicated by client marking)

UD01 has a specified width of 2m (as per Figure 4) and an overall length of 300m giving a total area of 600m². The centreline of this drain was paint marked by the client but not surveyed. Minimal working room was searched. UXO survey and investigation was conducted on 28 Aug 2014 with 28 anomalies investigated, all general scrap.

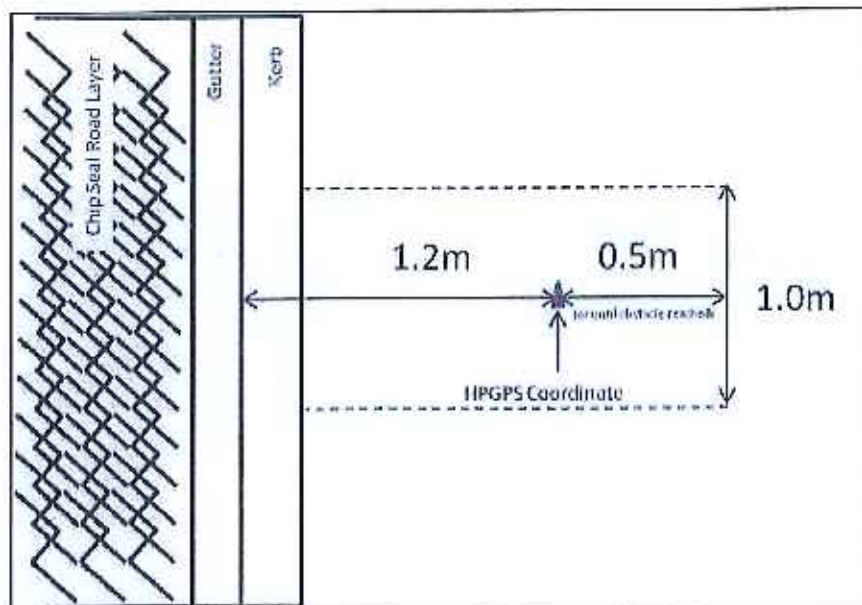
The SL have a specified distance from the kerb between 1.2-1.5m (varied as the ground allowed as per Figures 5 & 6) with a 1m² box cleared around the centrepoint. These points were not marked or surveyed by the client however a start point was indicated. Minimal working room was searched. UXO survey and investigation was conducted on 29 Aug 2014. In all, 65 points were identified at 100m spacing around Betio Island Main road with seven anomalies investigated, all general scrap.

Figure 5: SL Specified Search Area (SL13-16, SL21-26, SL29-34, SL37, SL39-40, SL59)

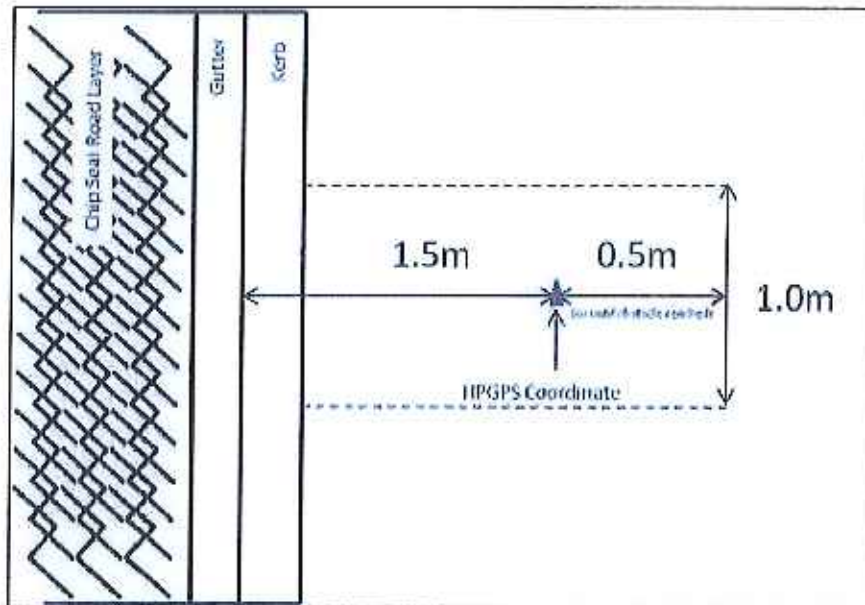
Figure 6: SL Specified Search Area (All Others)

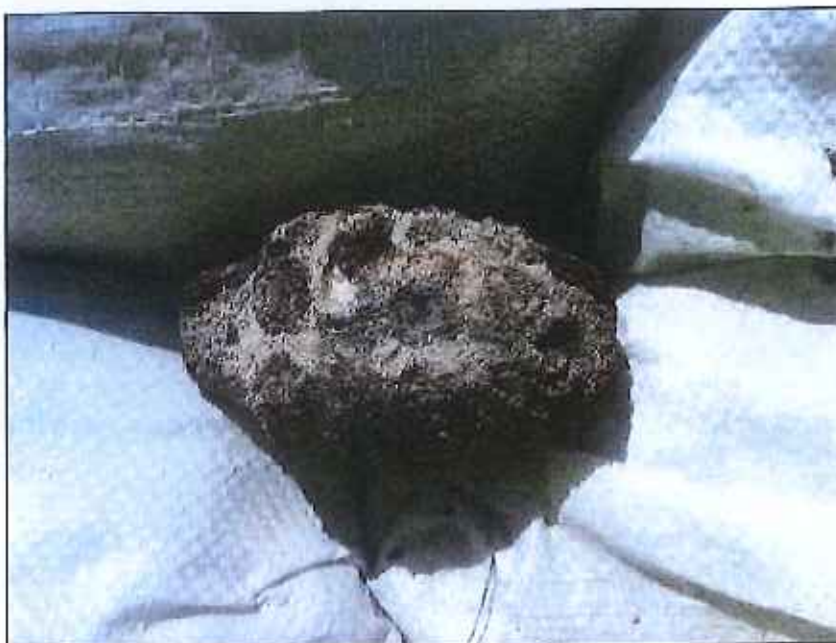
Plate 19: US MK2 HE Grenade (FRO8) UXO

Additionally, it is strongly recommended that all items of live UXO or EO only be handled, removed and disposed of by qualified and experienced EOD technicians. Should non-qualified personnel handle these items, the risk of an explosive incident occurring will be introduced.

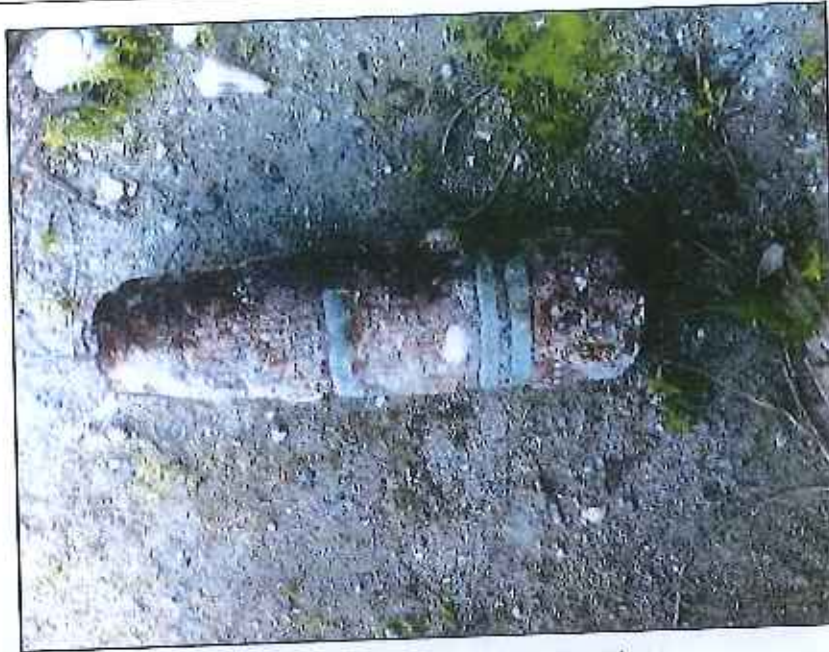
Plate 20: Jap Type 90 Projectile (FR08) EO

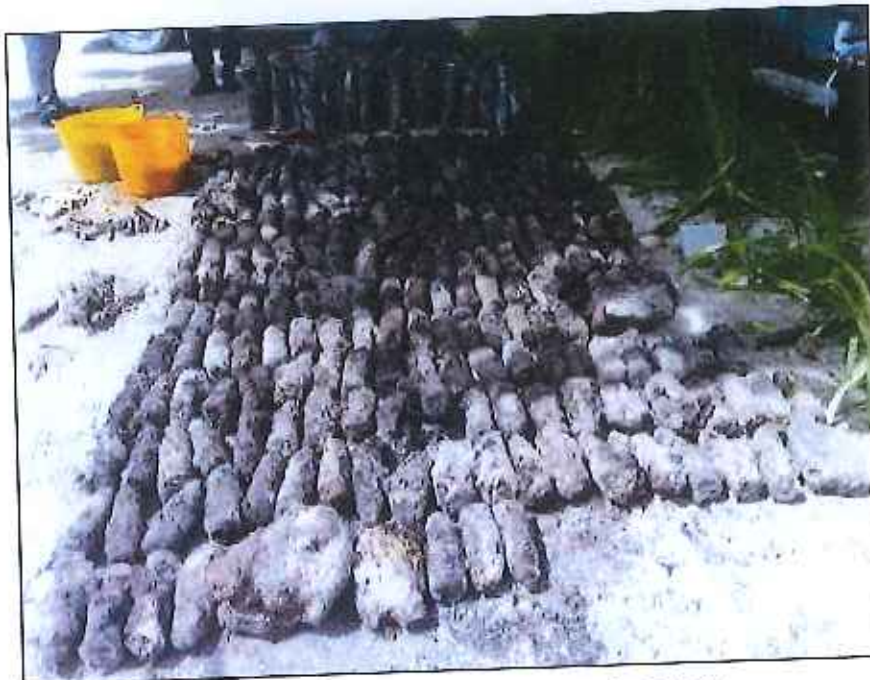
Plate 21: Jap 3\"

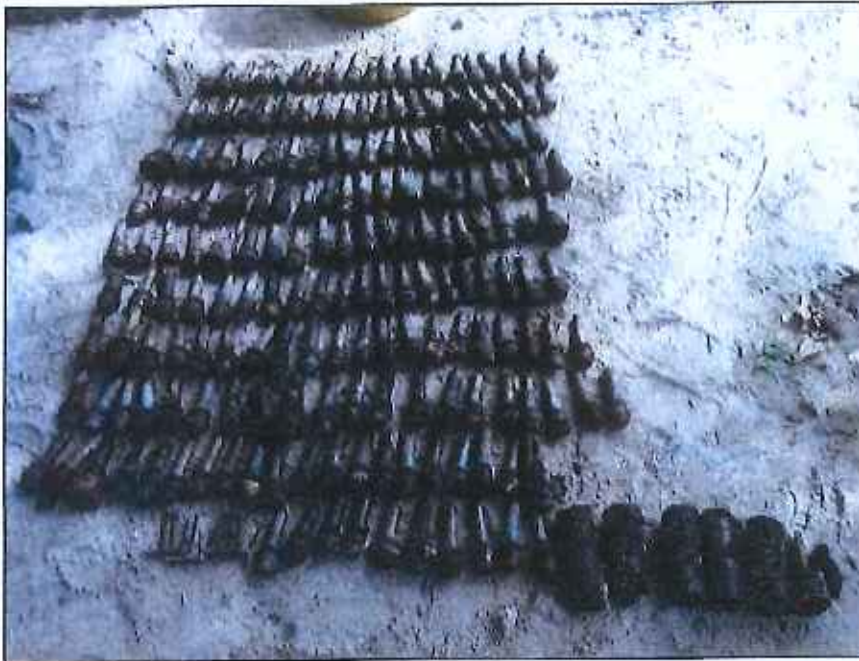
Plate 22: Jap 5th Year Fuse (FR06) EO

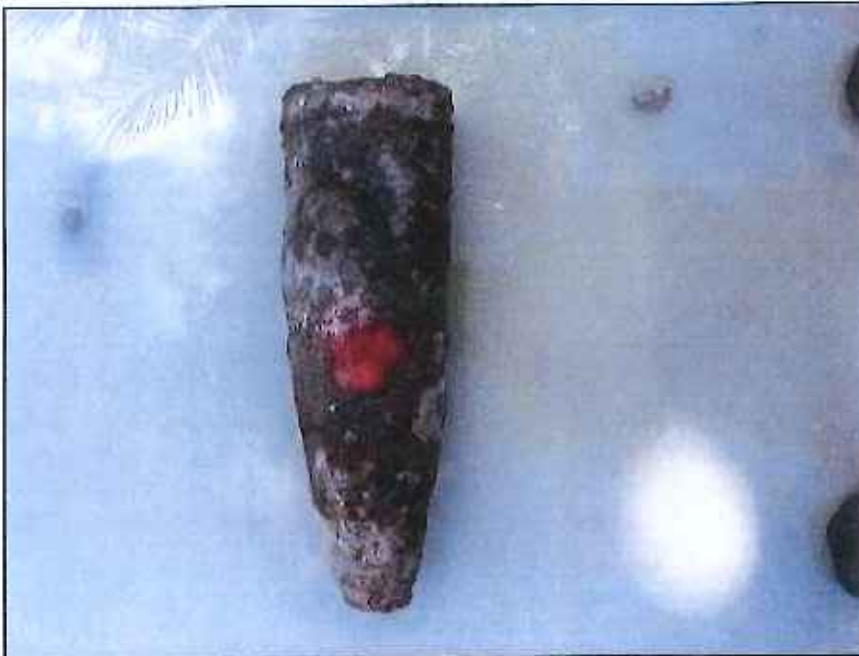
Plate 23: Jap 120mm Projectile (FR06) EO

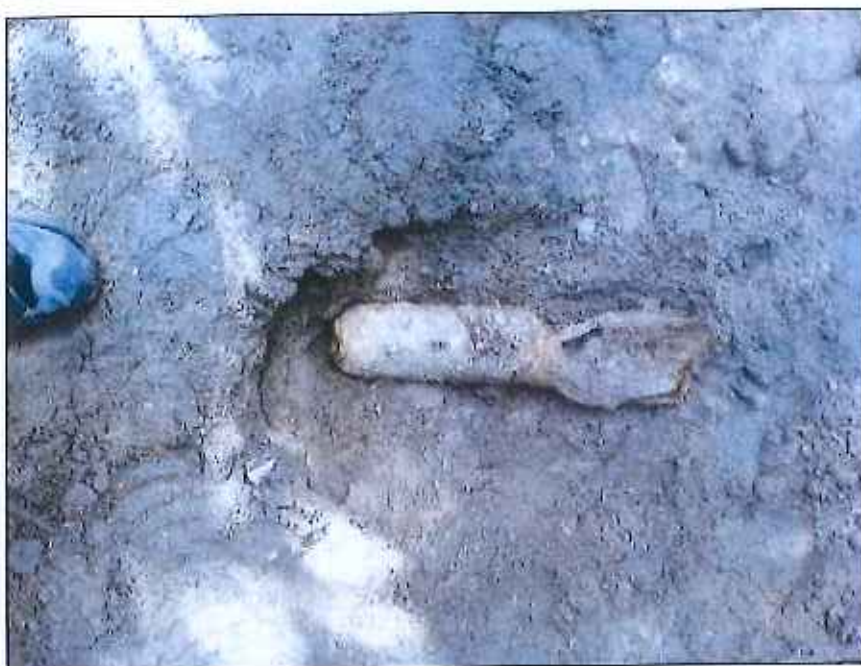
Plate 24: US AN-M41 20lb Frag Bomb (FR05) UXO

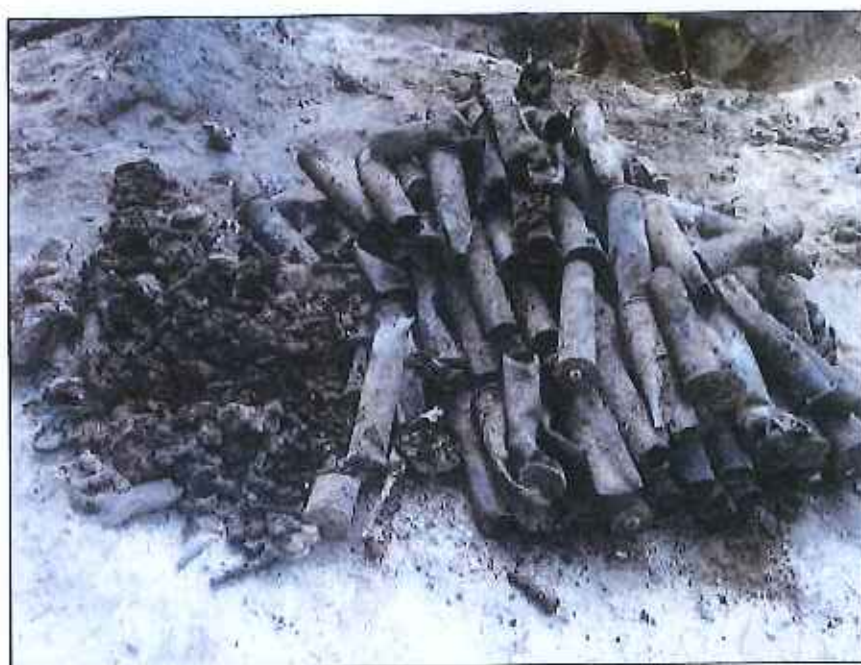
Plate 25: EOW Examples

A total of 4,817 anomalies were investigated. Of these, two items were identified as UXO with a further 587 items identified as EO. In addition, a further 22 items of SAA and 384 individual items of EOW were removed. The location of these significant finds is pictured at Figure 7 and examples are shown in Plates 18-24. All items containing explosives or energetic materials were transported to Betio Police Station and stored in their bunker. All items of scrap were disposed of for recycling.

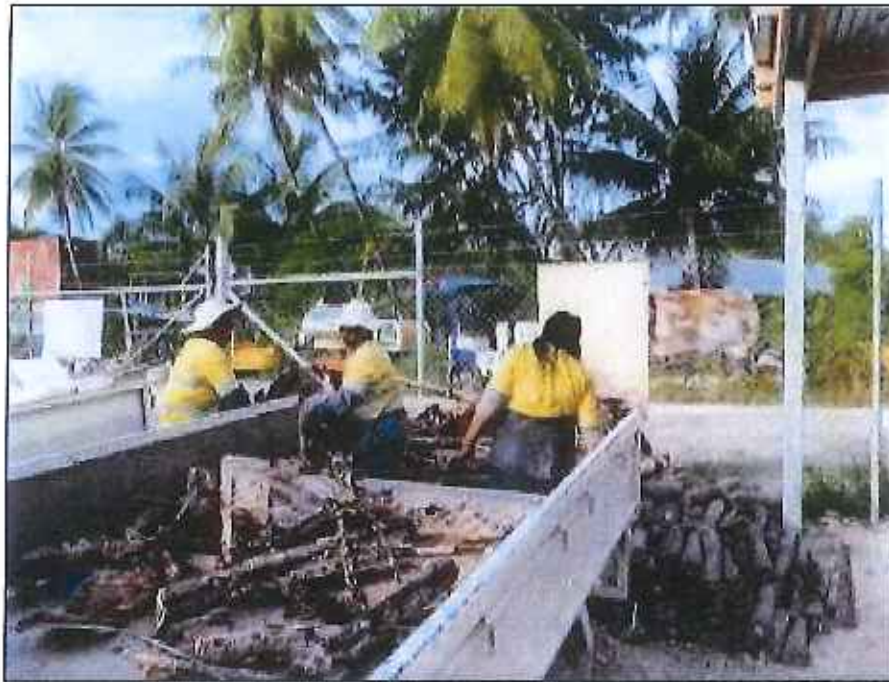
Many items identified during the Investigation process were scrap items arising from human habitation on the site as shown at Plate 27. In most instances the anomaly was removed during the clearance. The exceptions to this were large items such as reinforced concrete culverts, pipelines or, in the case of the WMR, large underground ferrous anomalies that were at a depth greater than the intended task depth or that were so large they extended beyond the specified width. Given these items were deeply embedded in the ground, once the anomaly was identified they were left in situ.

Plate 27: Scrap Examples

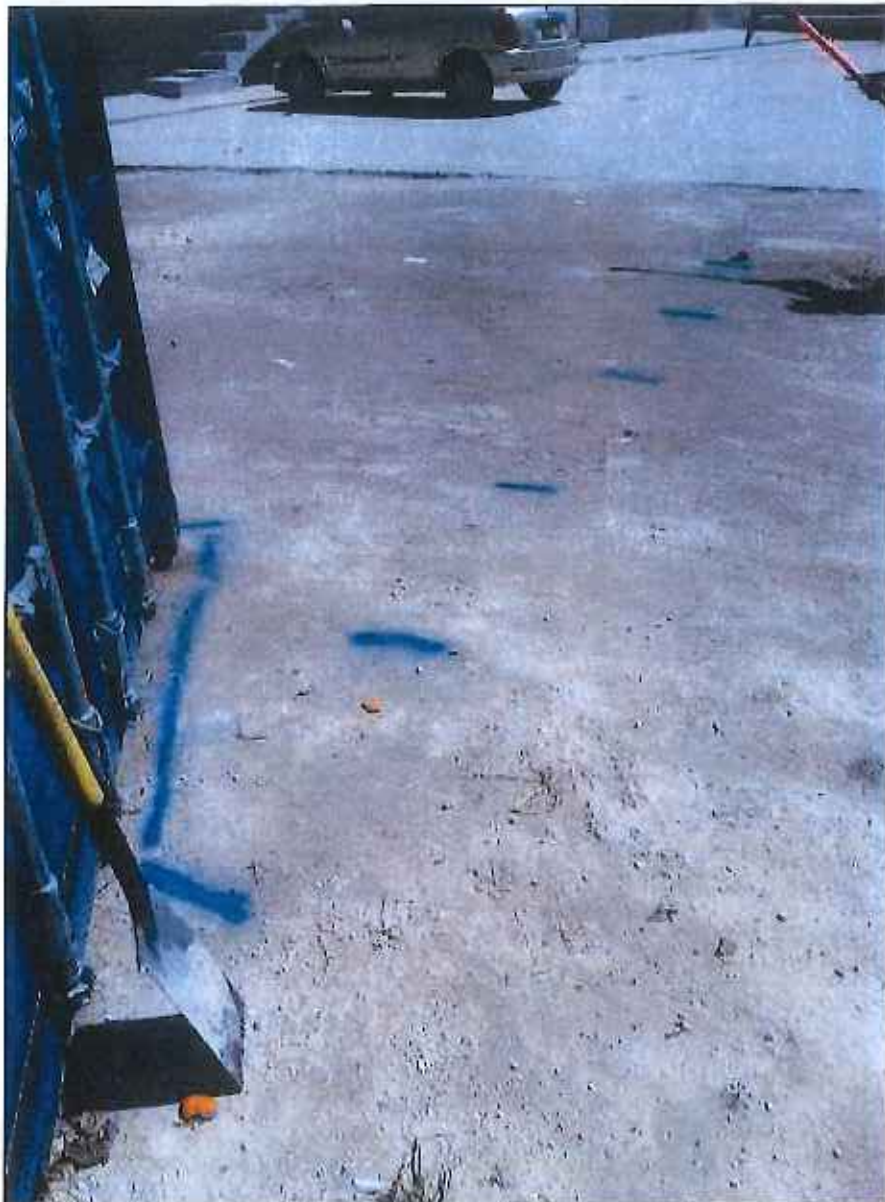
Route	Impediment
FR01	High Voltage Power between CL0-CL20 and along W edge of route
FR02	Two shipping containers impinged upon the route
FR04	Road narrows between CL50-100 & CL320-340
FR06	Power runs bisects the road. Runs along the north eastern edge of the road.
FR07	Numerous power cables across and along route
FR08	Numerous power cables across and along route
FR10	29 anomalies remain under the chipseal between CL355-425 as per the clients instructions.
FR11	94 anomalies remain under the chipseal between CL0-200 as per the clients instructions.
WMR	Several very large metallic anomalies between 1.5m-2m in depth were left in place. Power, communications and the Sewer also run along this same easement.
UD04	There is heavy electrical interference along this entire easement.

Plate 28: Container Impingement FR02

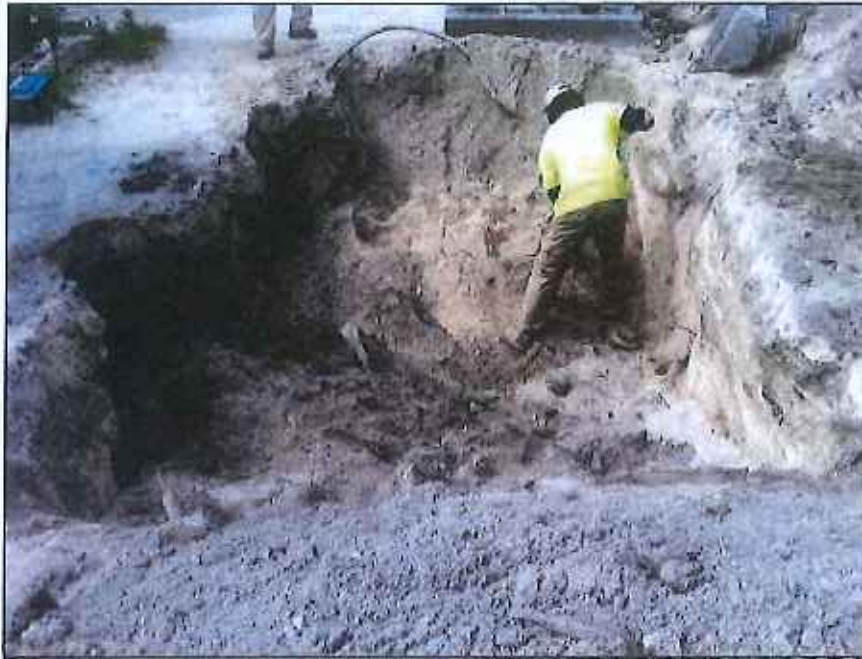
Plate 29: Electrical Cable Interference FR06

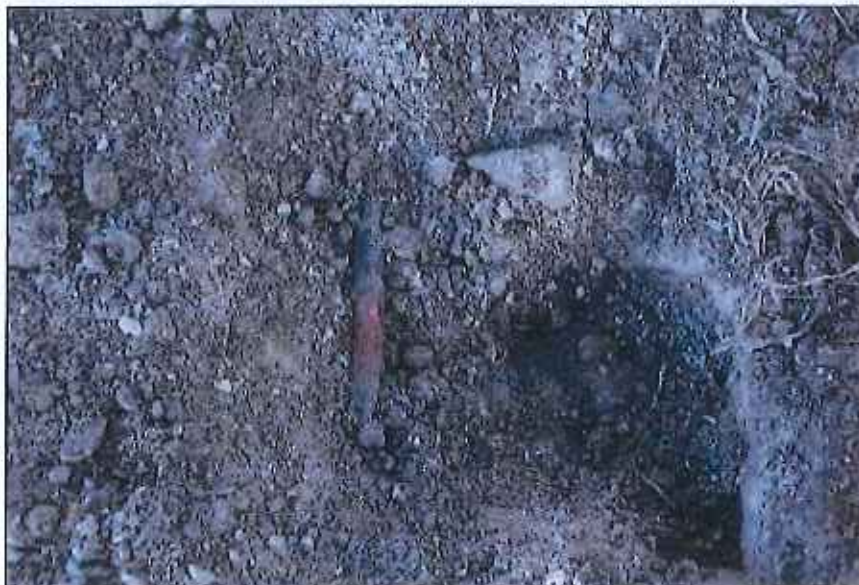
Plate 30: Shallow Electrical Cable FR07

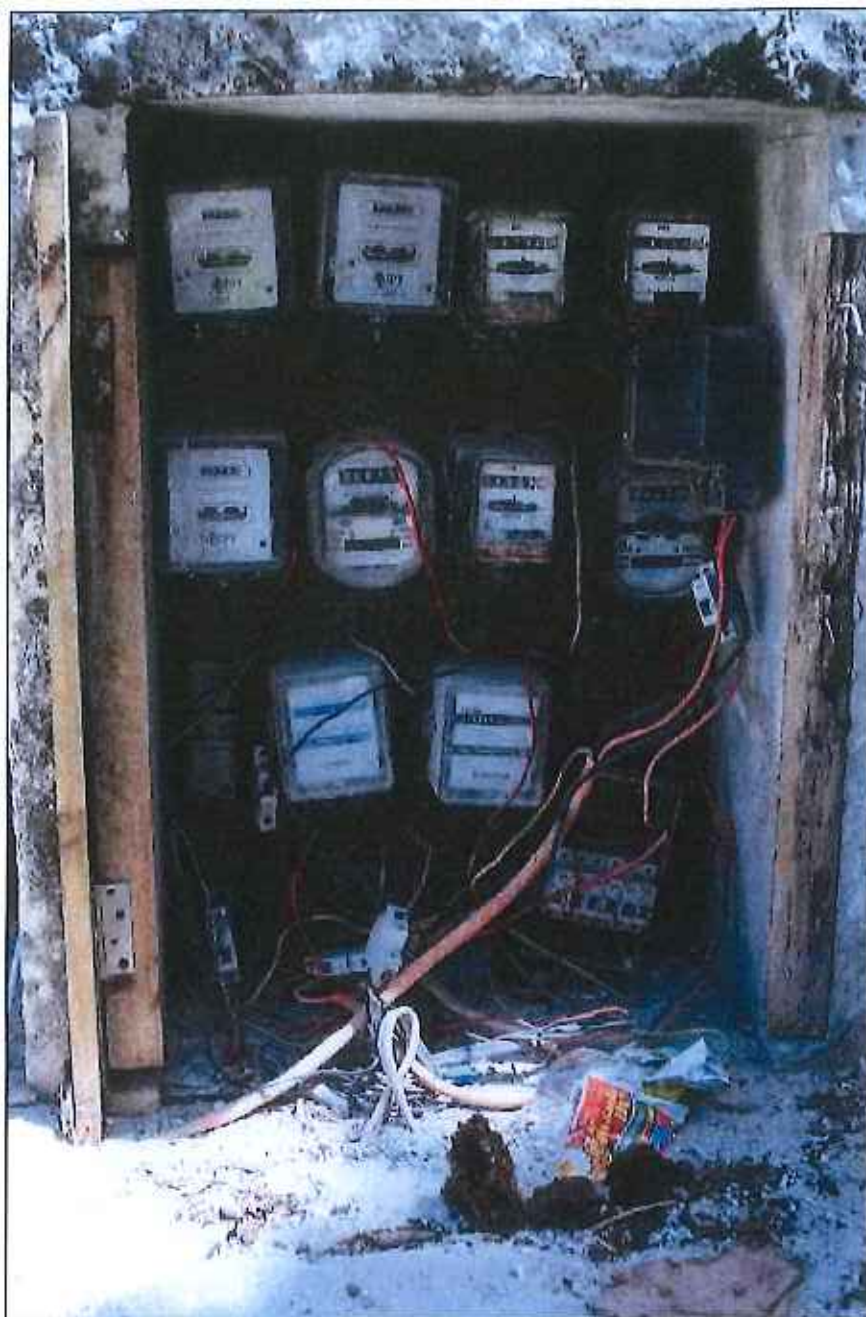
Plate 31: Electrical Cable Conditions FR04
