## **Kiribati Road Rehabilitation Project**

Consulting Services: Preparation of Design  
and Construction Supervision of Road  
Rehabilitation Works

## **Construction Phase Quarterly Progress Report**

**December 2014**

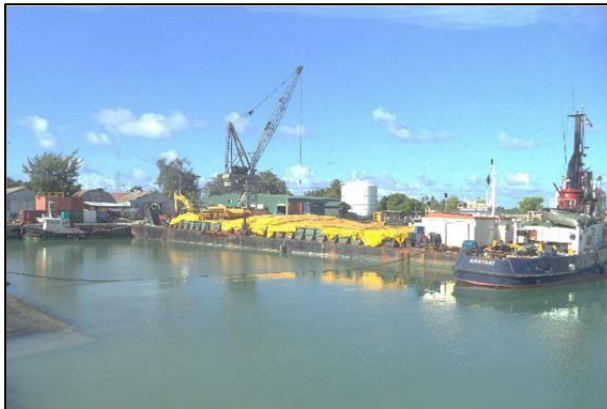
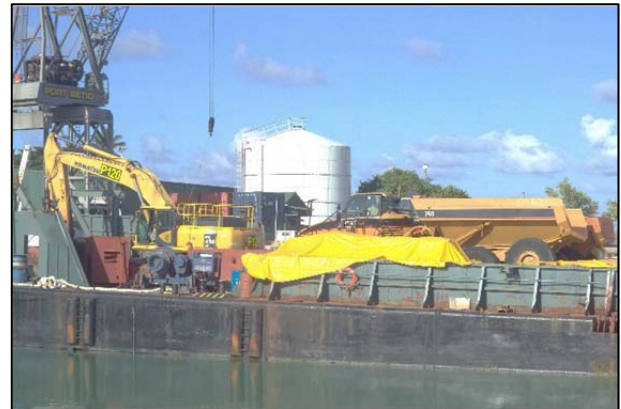
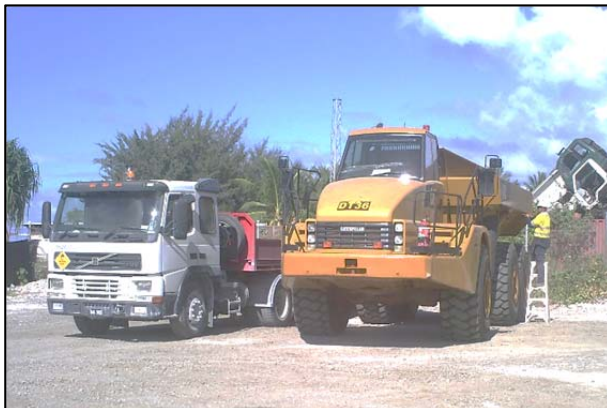
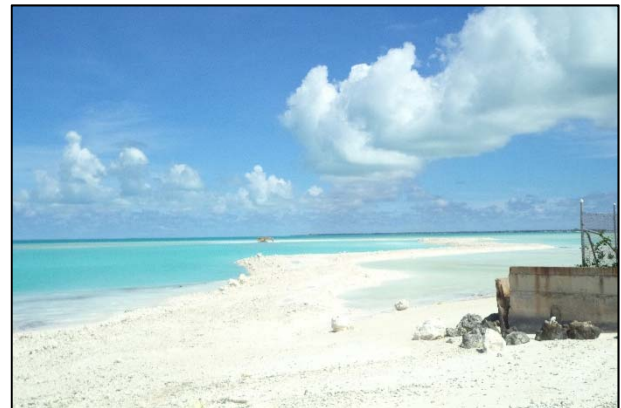
The Contractor has now entered into a formal contract with Te Atinimarawa Co. Ltd. (TACL) for the supply of coralline materials. Equipment (1 x 45t excavator and 2 x 10m<sup>3</sup> articulated dump trucks) has been mobilised and, although initially targeted for arrival in September 2014, arrived Tarawa on 18<sup>th</sup> November 2014. Following equipment checks etc works on the 'haul' road commenced on or around 4<sup>th</sup> December 2014 and, towards mid-December, access to the main channel excavation area had been established. The Contractor has started to stockpile some coral materials however the main thrust of activities can be expected when the Contractor returns early-2015 after the Christmas/new year shut-down.
