## ***Safeguards Monitoring Report***

8th Semi-annual Report

Project No. 49450-021

Kiribati: South Tarawa Renewable Energy Project (STREP)

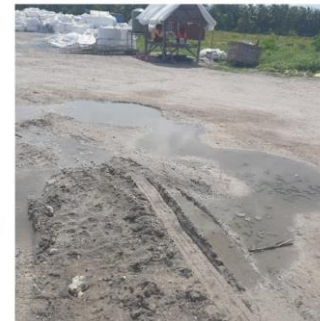
Photo 1: Storm water trapped.
